Septic System Inspections and Biomat Evaluations in the Georges Pond Watershed

Maine Lakes & Lake Stewards of Maine Joint Conference June 17, 2023

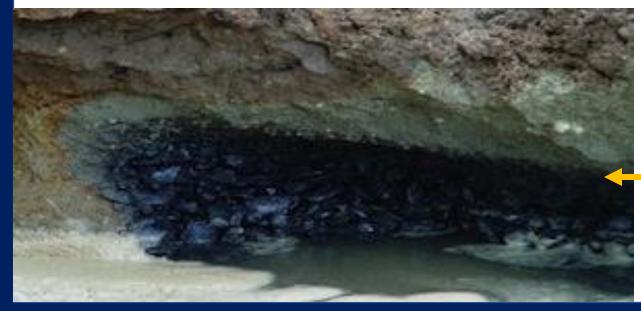
What is a "Biomat"?

- Black "slime" layer formed at the soil interface in the leach field
- Comprised of particles escaping the septic tank & the bodies of dead and living microbes
- Provides significant pathogen reduction
- Indication there is <u>NO</u> Short Circuit
- Does not significantly reduce nutrient levels

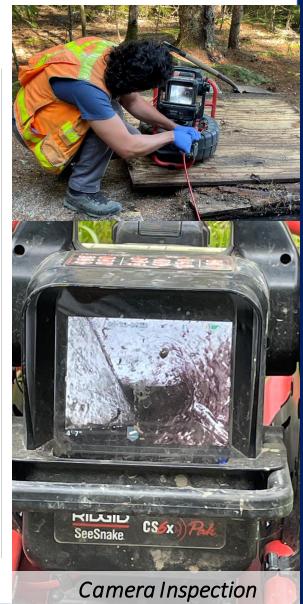
- Two pre-1974 Systems
- Metal Tanks & Unknown Leachfields

- Sandy Loam Soils
- Main house tank ~ 25 ft from the lake on a side slope toward the lake
- Shower house tank >100 ft from the lake on level ground separated by a berm

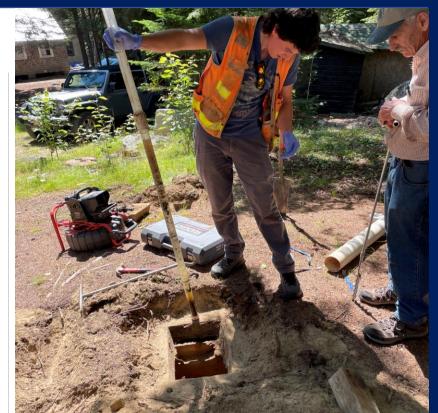
- Seasonal Cottage
- 1993 Septic System
- HHE-200 Form on file
- Concrete tank w/proprietary disposal device

- Fine Sandy Loam w/Pan
- Site sloping away from the lake

- Ponded effluent in the disposal field (evidence of Biomat)
- System functioning properly
- No short-circuit

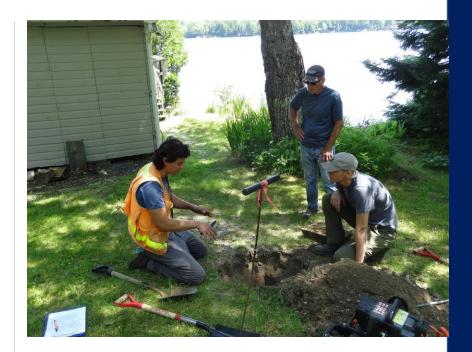
- Seasonal Cottage
- 1992 Septic System
- HHE-200 Form on file
- Concrete tank w/stone bed disposal field
- Design by same site evaluator and soil type as System # 2

Site Conditions

- Sandy Outwash Soils
- Disposal field across the road from the lake

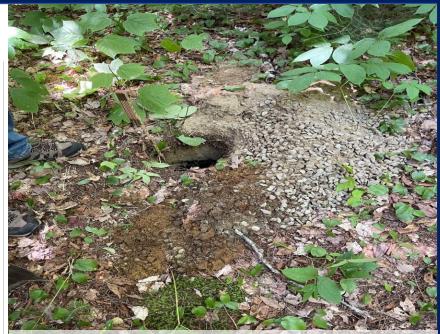
Clean stone- no evidence of Biomat

- <u>No</u> evidence of Biomat
- Tree roots present in sand below disposal field stone (nutrient uptake)
- Short-Circuit

Moderate threat to lake, replacement <u>NOT</u> immediate

- 1) Limited Seasonal Use
- 2) Distance to the Lake (several hundred feet)
- 3) Higher priority if usage increases significantly and/or used year round

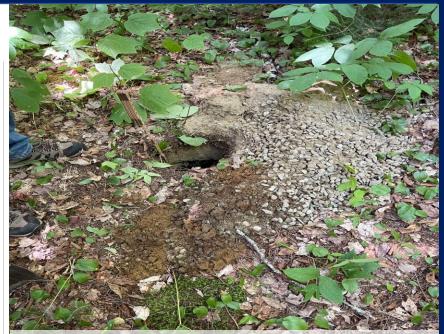
Clean stone- no evidence of Biomat

- <u>No</u> evidence of Biomat
- Tree roots present in sand below disposal field stone (nutrient uptake)
- Short-Circuit

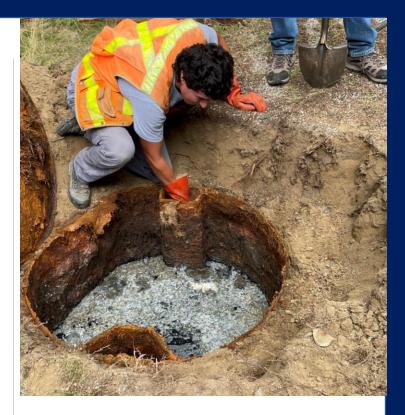
- Seasonal Cottage
- Pre-1974 Septic System
- 300-gallon metal tank w/unknown disposal area

- Replace with modern system
- Owner has replacement system designed
- Costly due to slopes & set-backs

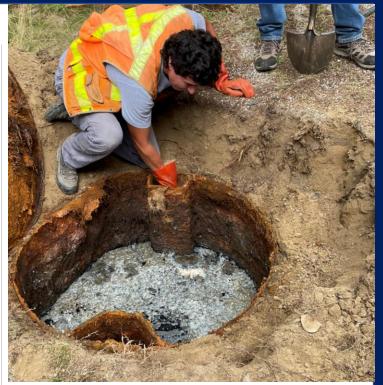
- Outlet of septic tank plugged w/roots
- Holes in septic tank
- Tank undersized
- Low levels of effluent

- System needs replacing but not deemed a significant threat as currently used
 - 1) Fine sandy loam soils not likely to short-circuit
 - 2) Septic tank holes acting as cesspool
 - 3) Elevate to moderate priority <u>if usage increases</u> significantly due to threat of seep into drainageway

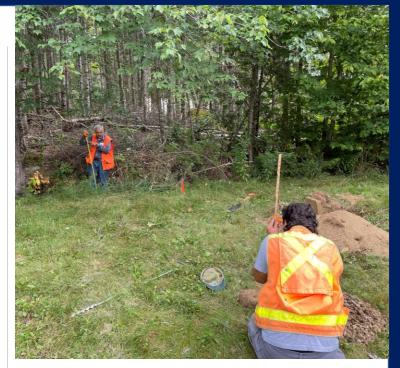
- One of the disposal field pipes located in gravel a couple of feet from excavated ditch
- Bottom of stone in disposal field lower in elevation than bottom of excavated drainage ditch
 - Direct connection to the lake
 - Would likely have surfacing effluent if not for the connection to the ditch

- Disposal field is a <u>significant threat</u> to the lake- Highest Priority
- Replace as soon as possible
