Bolton Lakes & Watershed Management Plan

Prepared by Northeast Aquatic Research LLC

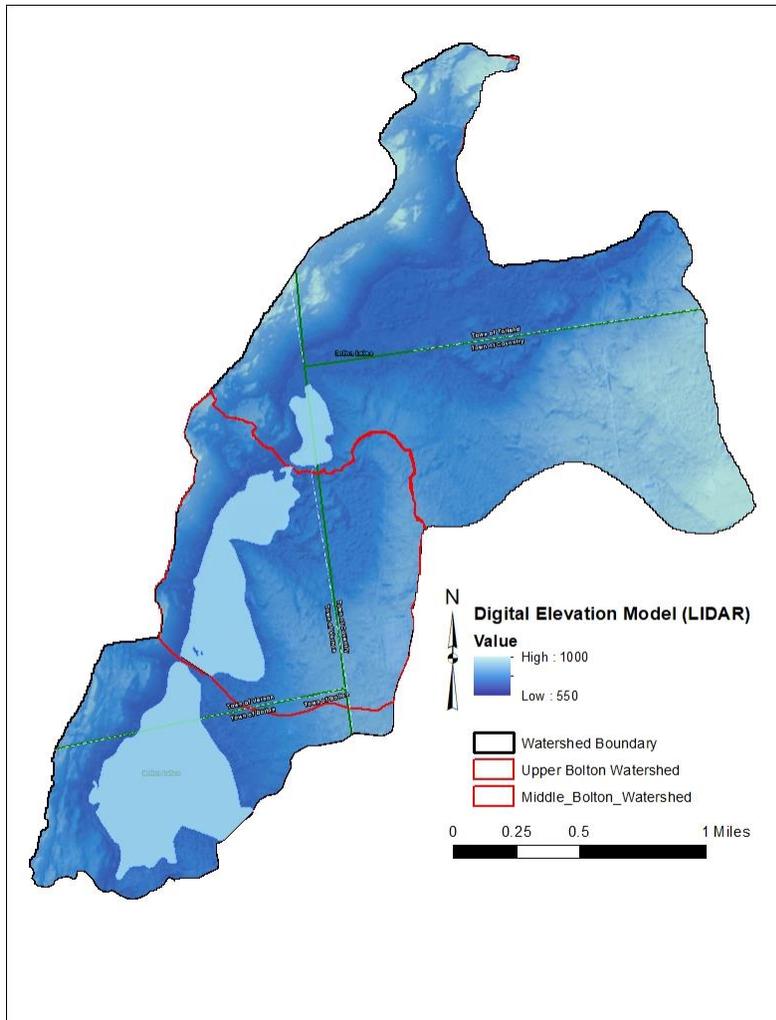
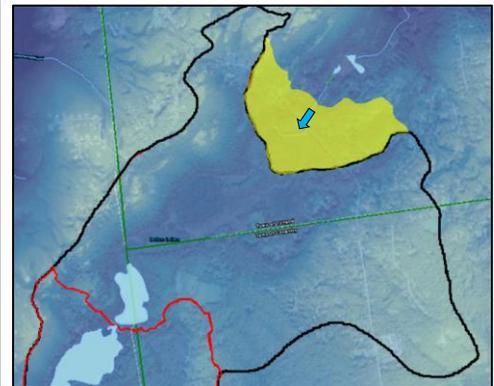
Map 1: Bolton Lakes Watershed Boundary

There is a questionable flow area along Mile Hill Road and Gehring Road in the northeast. The topographic flow contours indicate that water flows north under Mile Hill Road, but that was not the case during the field inspection in November 2020, where water was observed flowing south. The additional proposed watershed area needs more investigation and could add roughly 180 acres to the Upper Bolton watershed. However, this questionable area would flow to the Upper Bolton wetlands, meaning it should not substantially influence the water quality of Middle and Lower Bolton Lakes.

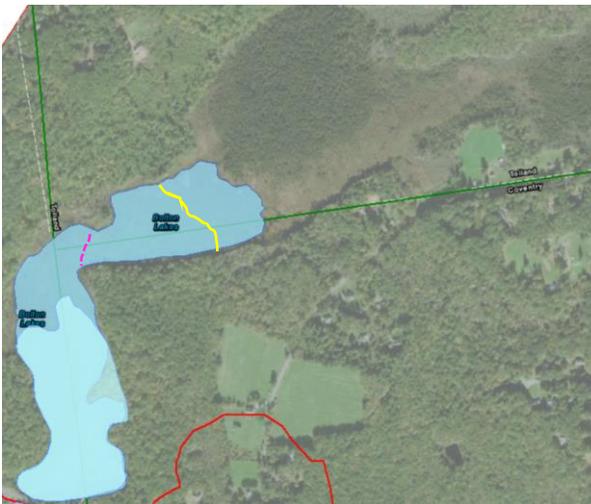
Photo 6: Upper Bolton - October 2020

The above Upper Bolton Lake photos were taken roughly at the central location of the yellow line. Waterlilies were dying back in October 2020 and water depth at the time was roughly eight inches. The second photo shows the transition area, from water/lily-coverage to peat-lands and swamp, with the Atlantic White Cedar Forest to the northeast. The red arrow points roughly north.

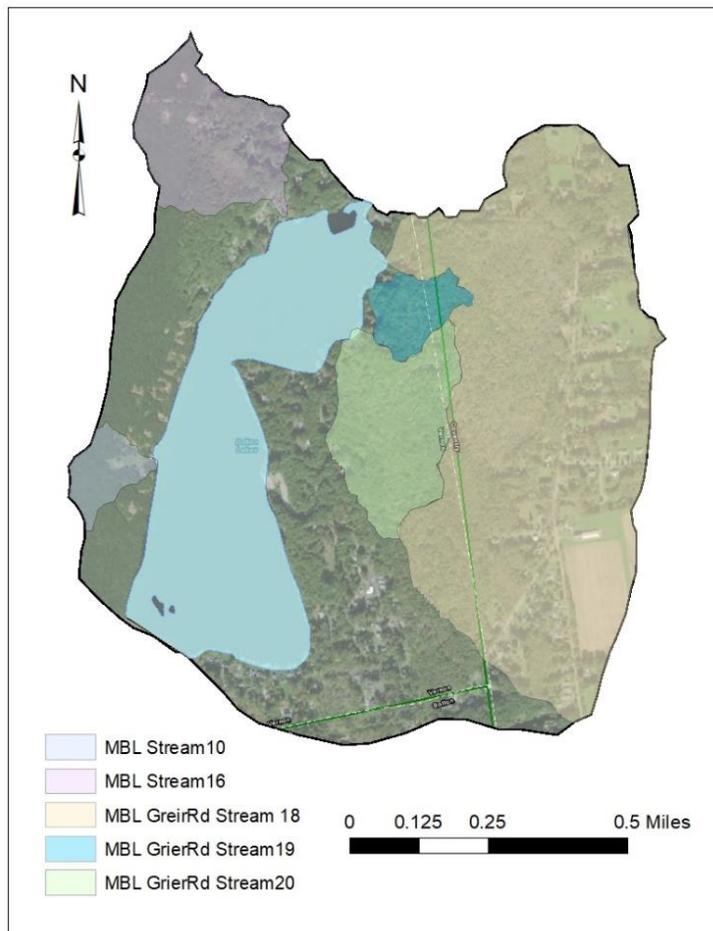
Map 3: Middle Bolton Lake Direct Watershed

Middle Bolton Lake (MBL) outflow to Lower Bolton occurs over the dam spillway at the south end. Water is also released, during winter predetermined drawdowns, to Lower Bolton Lake through the underwater 36” culvert on the western side of the earthen dam. Water flow over the Middle Bolton spillway is minimal from the end of June through the fall but depends on seasonal rainfall. Flows between the lakes vary heavily from one year to the next based on annual patterns of precipitation. The main MBL inlet streams are delineated in Map 3 and respective acreages displayed in Table 3.

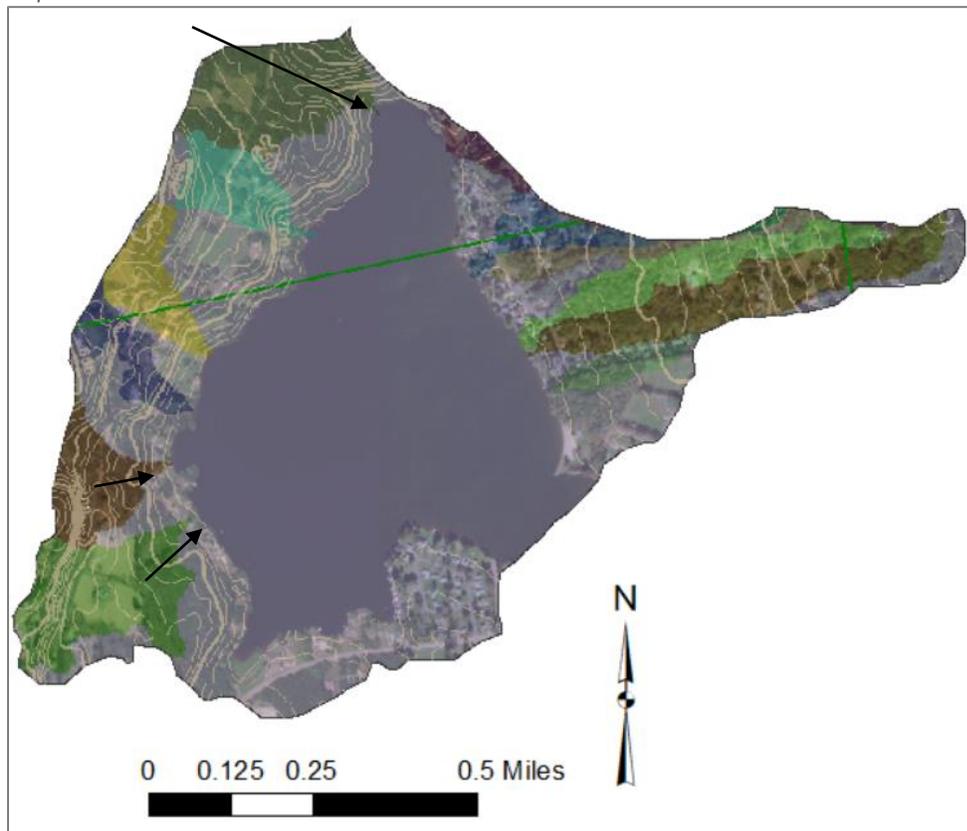
Map 4: Lower Bolton Lake Direct Watershed

The figure below demonstrates the direct drainage subbasins to Lower Bolton Lake. The eastern and southern sides of the lake are relatively flat, and water flow is primarily through stormwater runoff from the surrounding neighborhoods. The western ridge is steeper and has two small stormwater streams that flow onto Vernon Road and into the roadside swales during heavy rain. The northern wetland stream is the only Lower Bolton inlet stream that has water flow during non-storm conditions, but it typically runs dry from July to October, except during heavy downpours. The black solid arrows represent the general direction of water flow. The additional colored overlays show the general direction of concentrated water/base-flow towards the lake at the location of the wetland stream. For the purposes of this watershed plan, the Lower Bolton immediate watershed is all considered direct drainage. The annual drawdowns are pre-approved by CT DEEP and coordinated between the Towns of Bolton and Vernon each fall, through the 30" culvert that is positioned 9' below the normal surface water level.

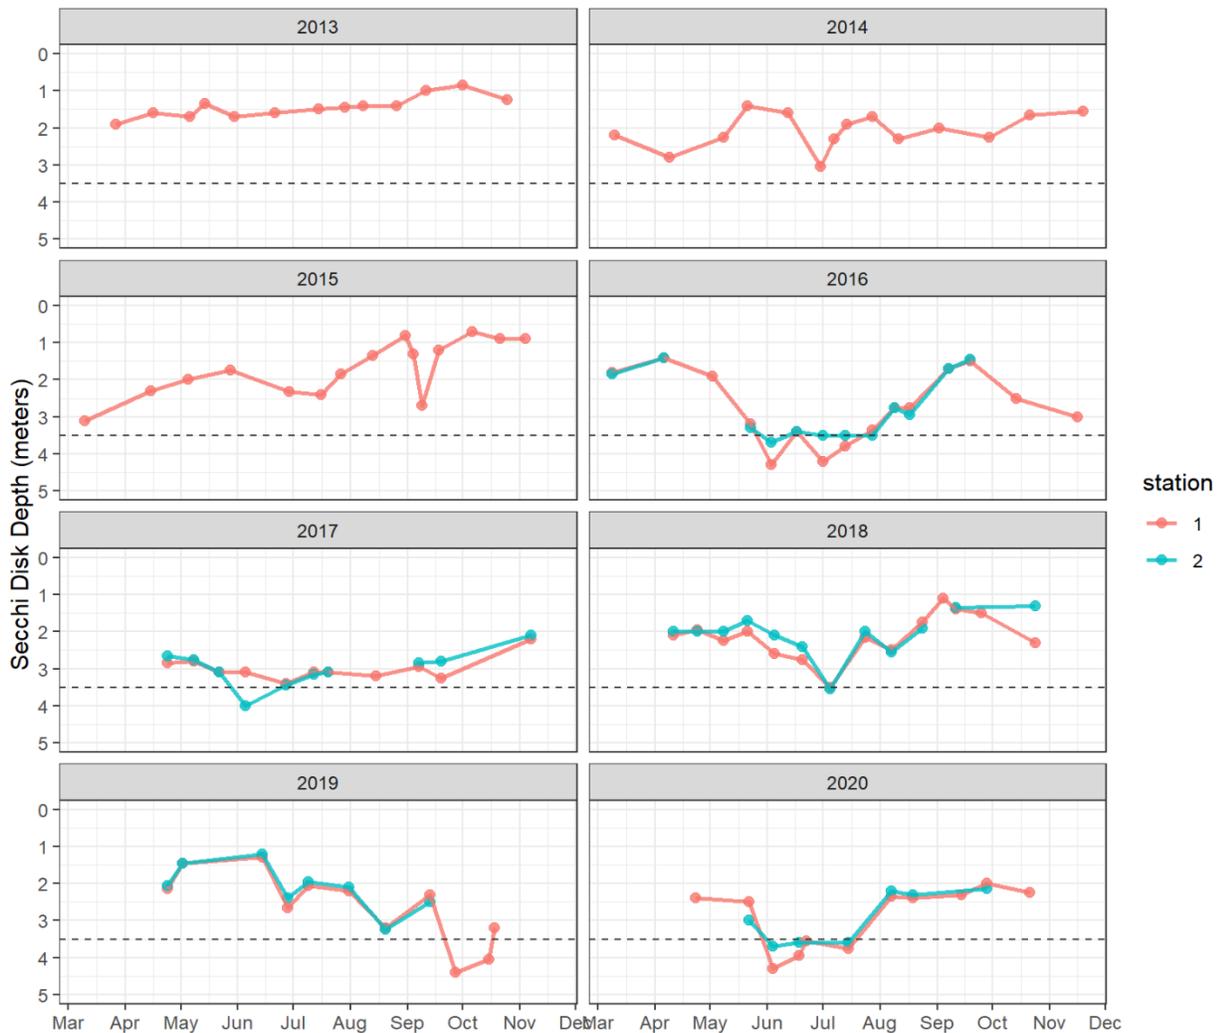
Figure 1: Lower Bolton Water Clarity (for consistency only NEAR values in this figure)

Horizontal dashed line indicates the approximate depth of Station 2 sampling area

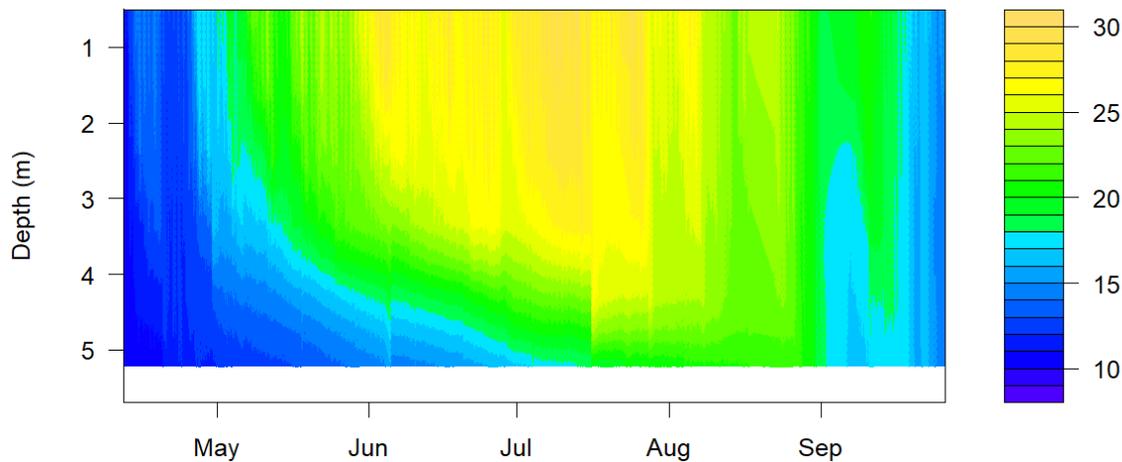
Temperature data was collected in two ways at Lower Bolton Lake: during monitoring visits in conjunction with dissolved oxygen profile monitoring, and through a string of continuous data loggers sponsored and maintained by FBL. Logger data, shown below, provides a detailed view of the thermal stratification and mixing events throughout the **Lower Bolton 2020 season**, much beyond what the traditional temperature and oxygen profile measures provide. It is the thermal stratification that allows for potential oxygen depletion in the deeper waters of the lake. Additional temperature profile data for Lower and Middle Bolton Lakes is available in raw data format, including high resolution 2021 temperature data.

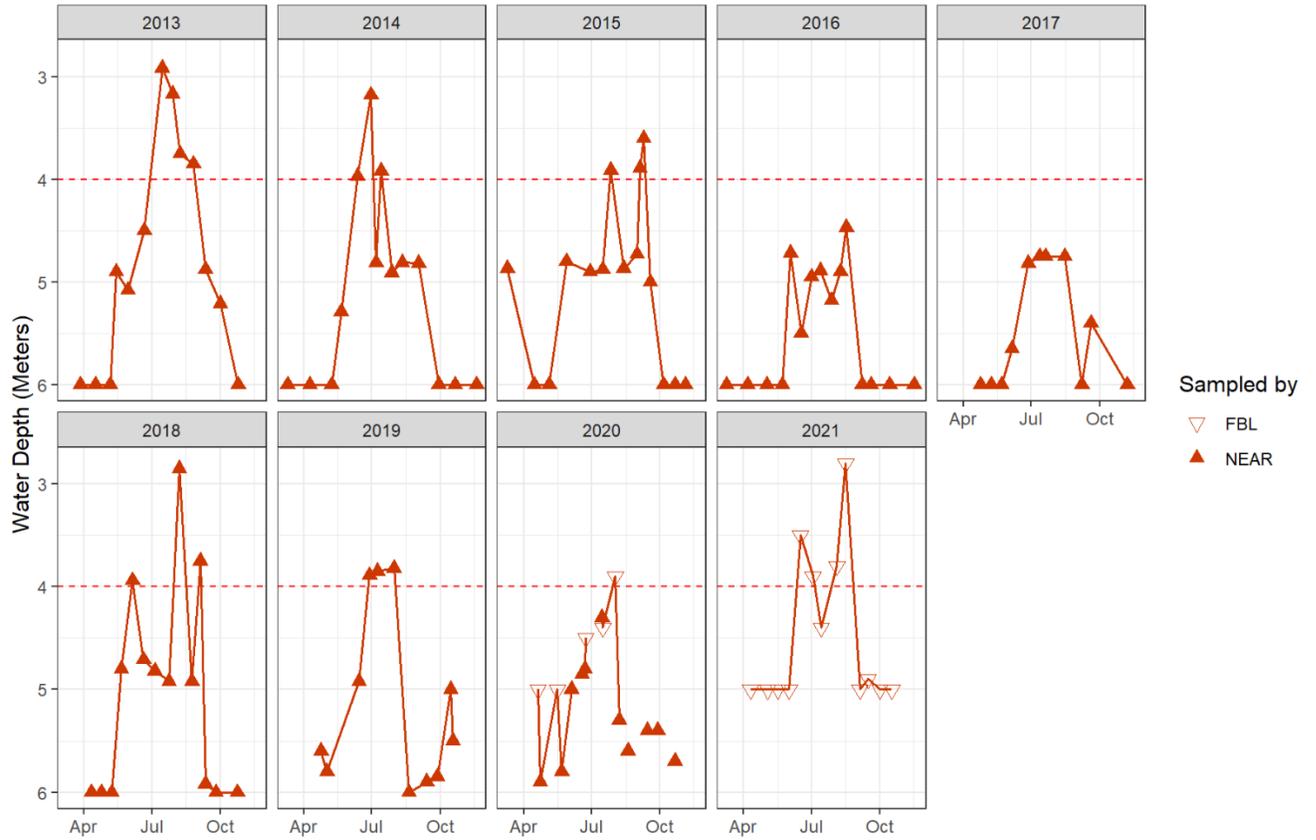
Figure 4: Lower Bolton Lake Anoxic Boundary 2013-2021

The average number of anoxia days was used in the determination of the internal sediment-release phosphorus mass estimates. As previously mentioned, the Middle Bolton goal for dissolved oxygen is for the anoxic boundary to be less than 1.5m off the lake bottom, or roughly 3.5m deep, indicated by the horizontal red dashed line. The goal for Lower Bolton is a 4m anoxic boundary in the deep hole station. The 2021 FBL monthly profile monitoring recorded the worst oxygen conditions of the season in June and July, with both values worse than the 4m target anoxic boundary (3.5m was the worst/shallowest anoxic boundary of 2021, recorded in mid-June).

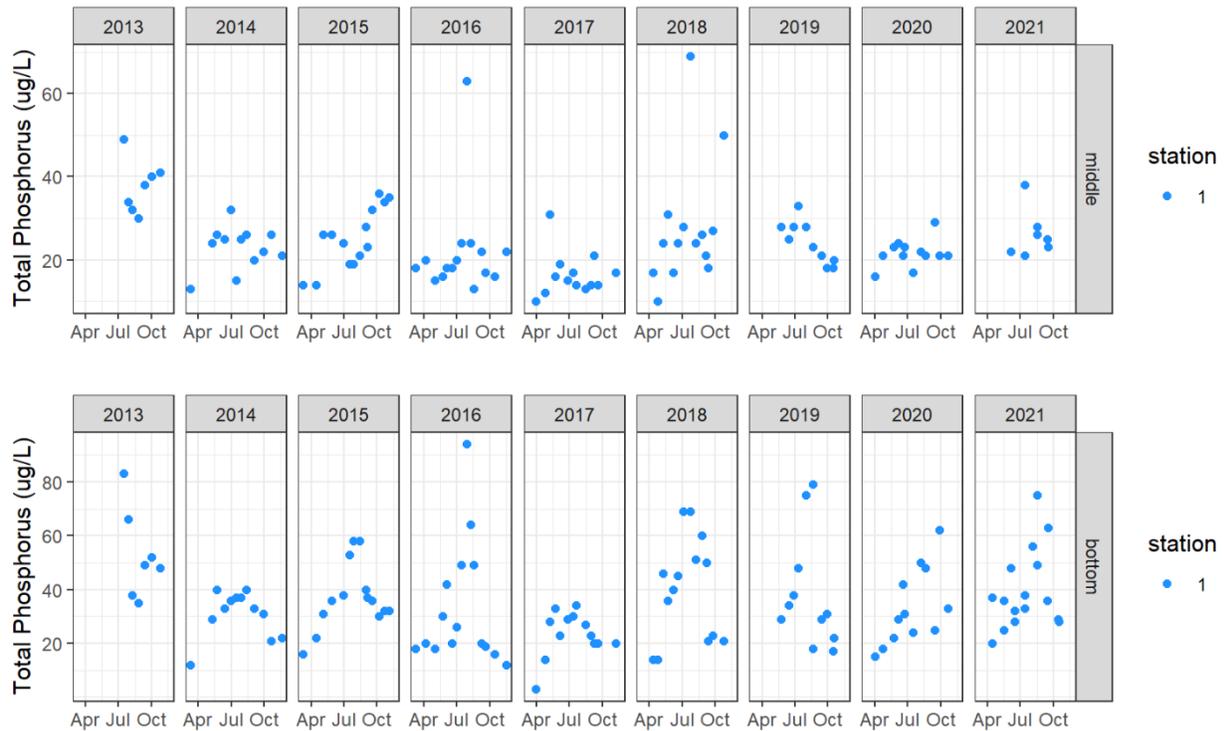
Figure 8: Lower Bolton Station 1 (Middle and Bottom-water Total Phosphorus concentrations)

Note that middle and bottom concentrations are significantly higher than surface concentrations, due to internal P loading.

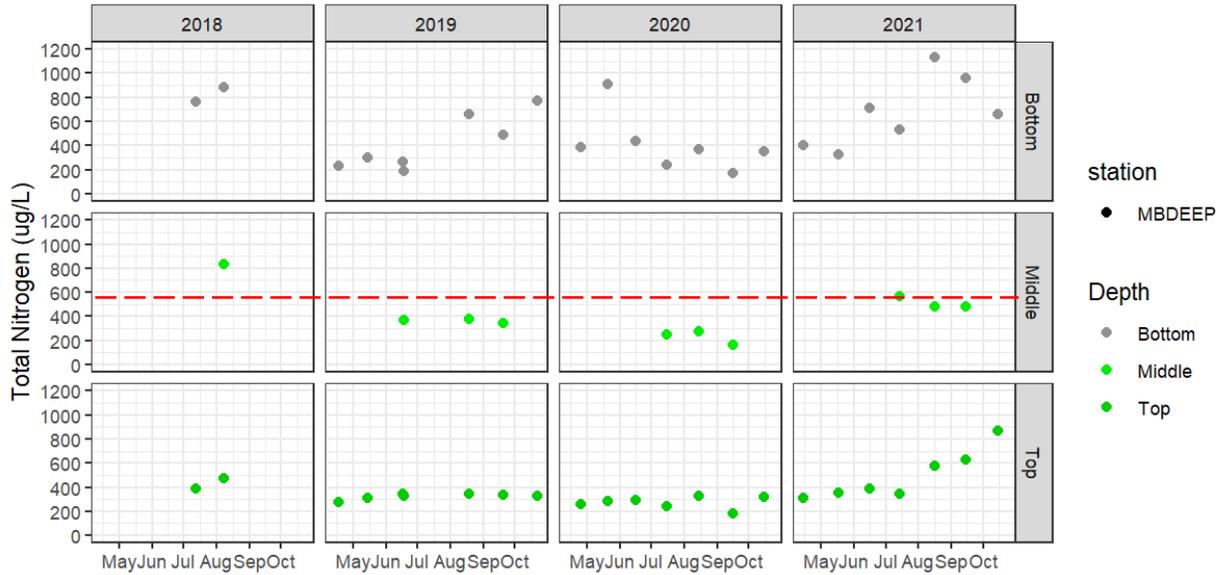
Figure 11: Middle Bolton - Total Nitrogen concentrations

Surface (Top) TN at Middle Bolton Lake exceeded the 600 $\mu\text{g/L}$ (ppb) eutrophic threshold on two sampling dates at the end of 2021, but on none of the prior samplings since 2018. The high TN in September and October 2021 coincided with a cyanobacteria bloom.

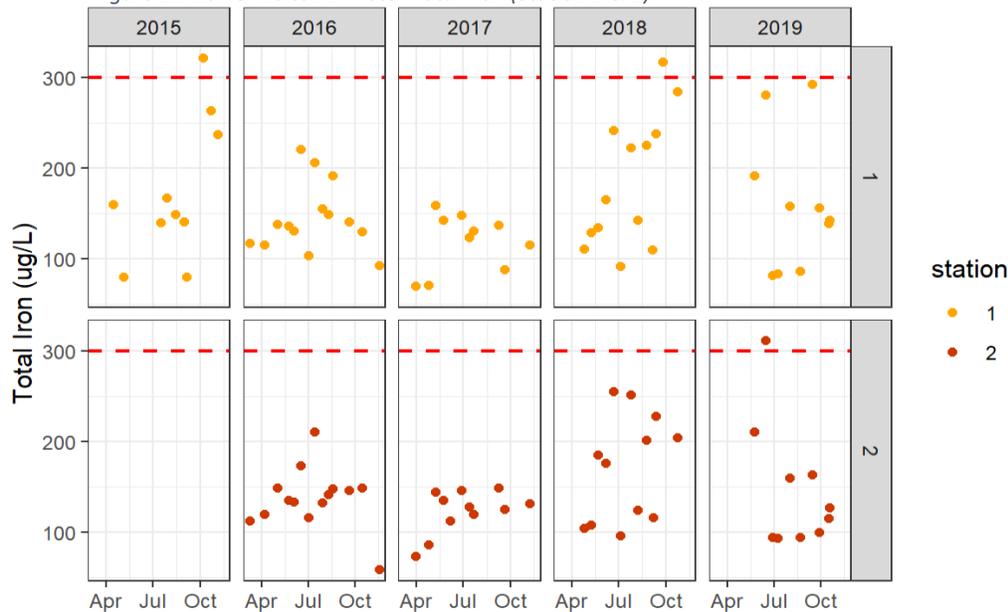
Figure 12: Lower Bolton 1-meter Total Iron (Station 1 & 2)

Total iron was measured in Lower Bolton Lake only. No iron data was measured in 2020. A subset of surface iron data, from 2015 through 2019, is displayed below. Initial investigation into the cyanobacteria bloom causes at Lower Bolton suggested that iron was a contributing factor, but recent years of water quality suggest that measuring total iron is not a good indicator of Lower Bolton Lake water quality, and high iron in surface waters does not always correlate with high phosphorus or nitrogen.

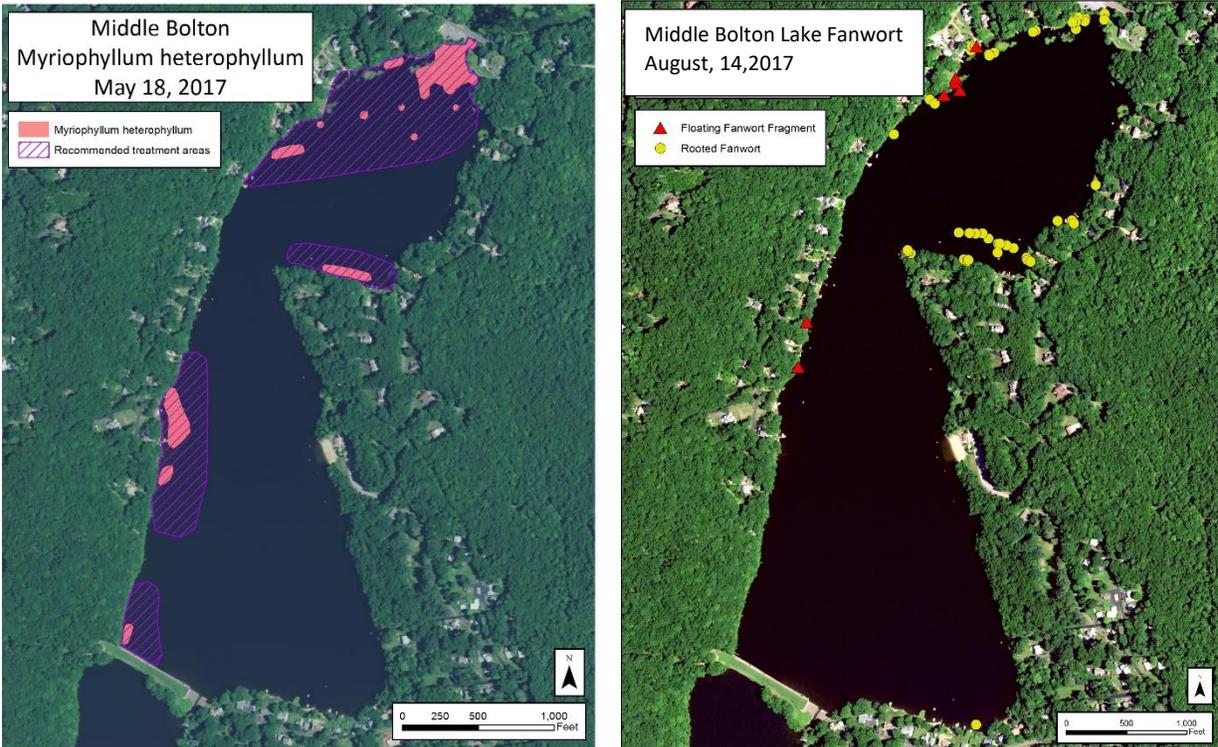
Map 6: (A) 2017 Invasive Variable milfoil (*Myriophyllum heterophyllum*) & (B) Fanwort (*Cabomba caroliniana*)

Fanwort was found in Middle Bolton Lake for the first time in July 2017. A full-lake aquatic plant survey conducted by NEAR found multiple locations that had Fanwort fragments or single rooted plants. All observed Fanwort fragments and single rooted plants were removed during the survey. Quick management action successfully secured a Clipper (flumioxazin) permit from CT DEEP, and the large Fanwort patches were treated by Solitude applicators in September 2017, within the first year of apparent infestation. Since the initial treatment, no Fanwort has been seen in the primary locations. The following maps show the locations of 2017 invasive Variable milfoil and Fanwort from their respective plant survey days. Because Fanwort tends to grow later in the season than Variable milfoil, full-lake Fanwort surveys tend to be conducted after mid-June.

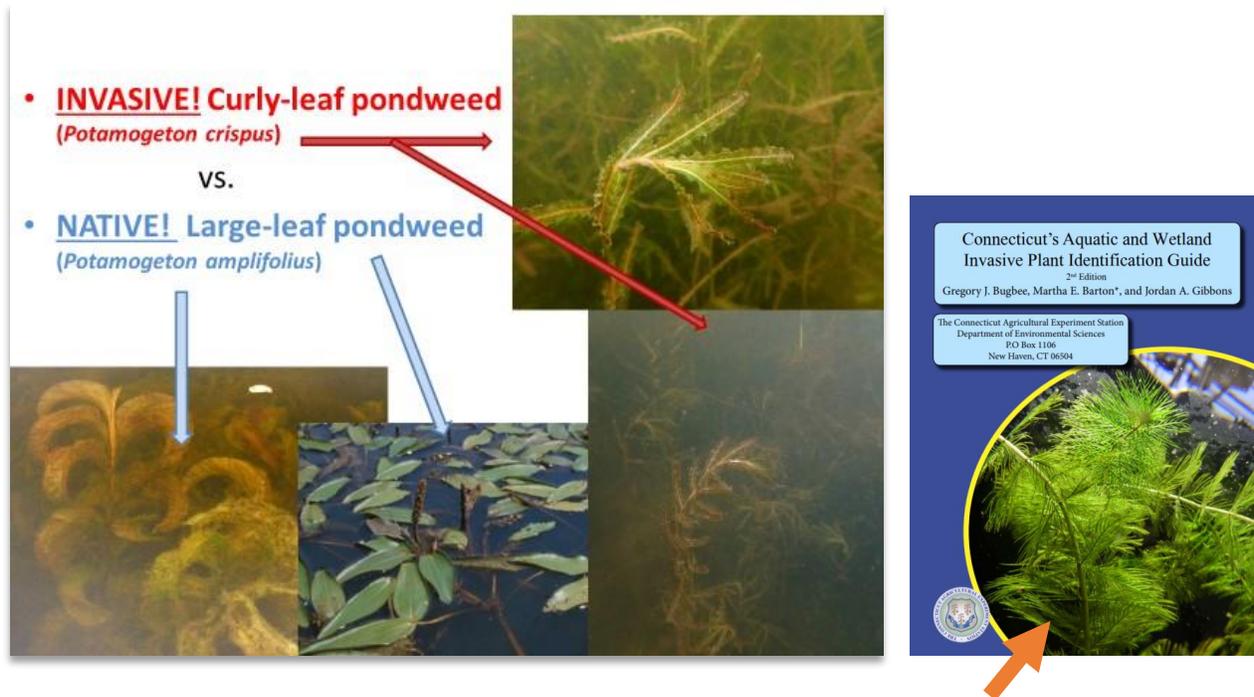
Curly-leaf pondweed is often confused with the native Large-leaf pondweed (*Potamogeton amplifolius*), which has much larger and broader leaves and does not have serrated edges. Large-leaf pondweed also has large floating leaves that reach the surface. The photos below demonstrate the difference between the leaves.

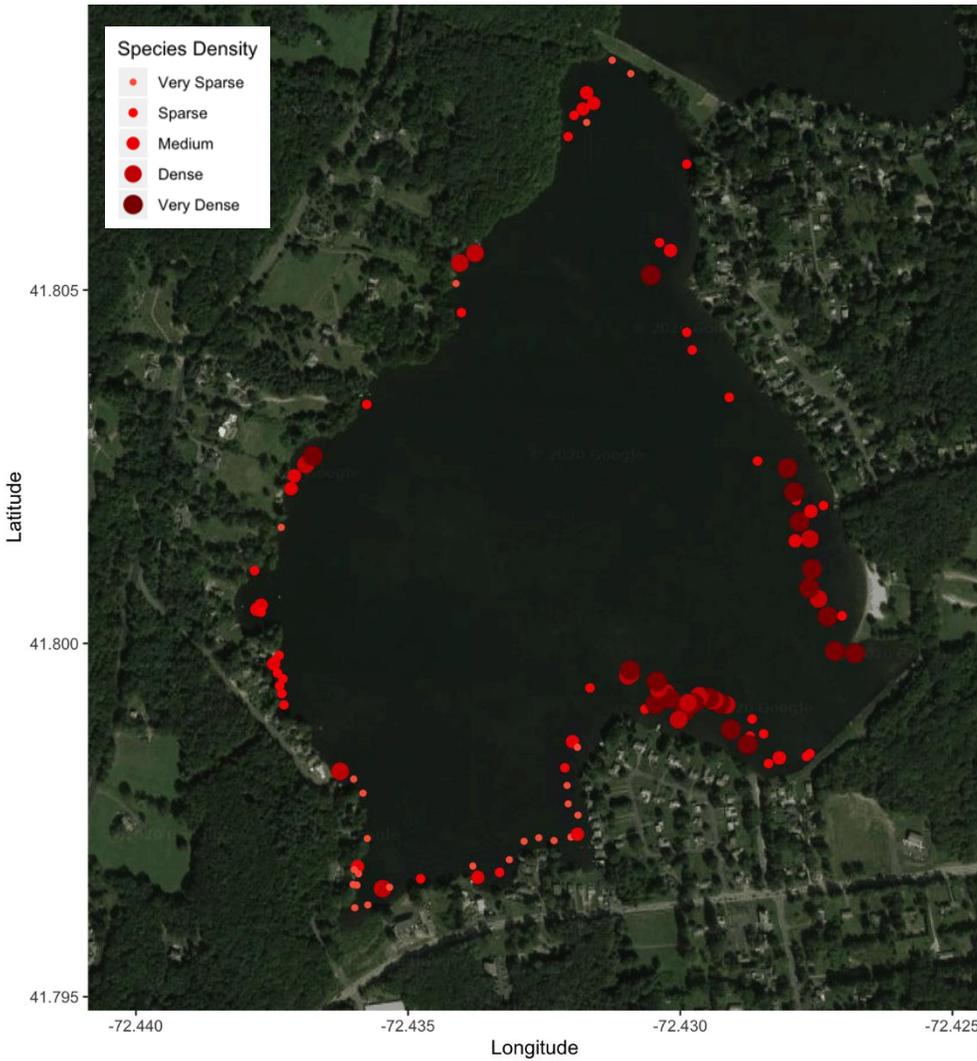
Map 10: Lower Bolton Invasive Curly-leaf pondweed (*Potamogeton crispus*) May 22 & Jun 22, 2020

Because of a permit issue, there was no herbicide treatment in 2019. The permit issue was resolved by the applicator in 2020, but by late June 2020, the invasive species had spread to new areas, particularly along the southwestern shore. The turion formation had begun prior to the 2020 treatment date, so we expected that another Curly-leaf treatment will be needed in 2021.

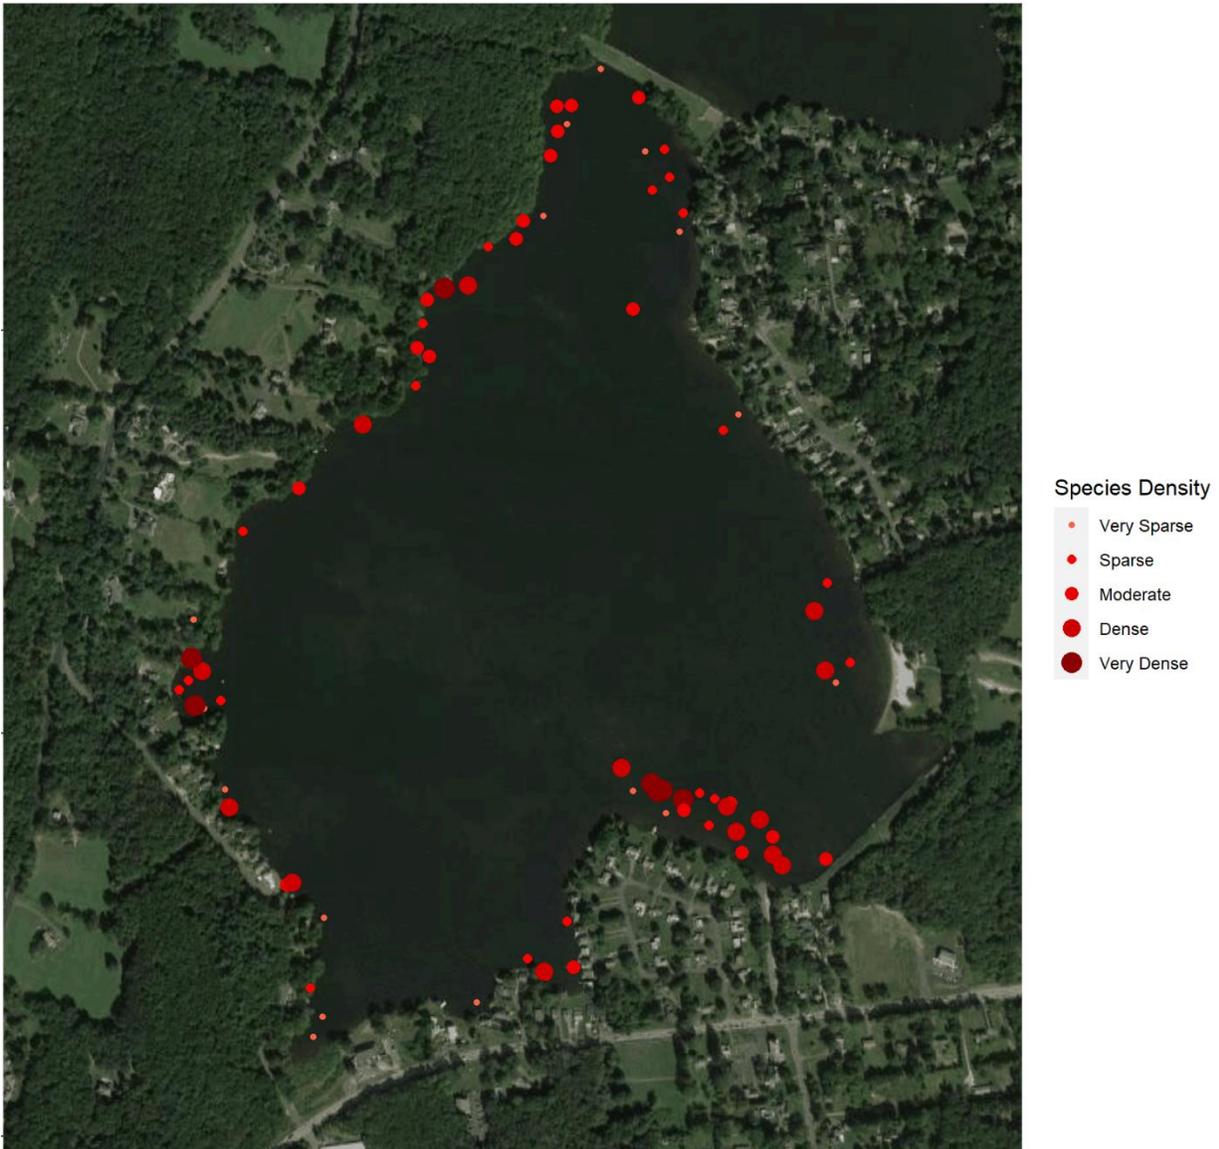
Map 11: Lower Bolton 5-24-21 Curly-leaf pondweed

Many areas where Very Sparse invasive Curly-leaf pondweed was found during the pre-treatment 2020 survey appear to have been successfully controlled by the 2020 treatment, as there were many locations found in 2020 that were not found during the 2021 pretreatment survey. There were, however, several new locations along the northwestern shore – likely a result of previous turion spread.

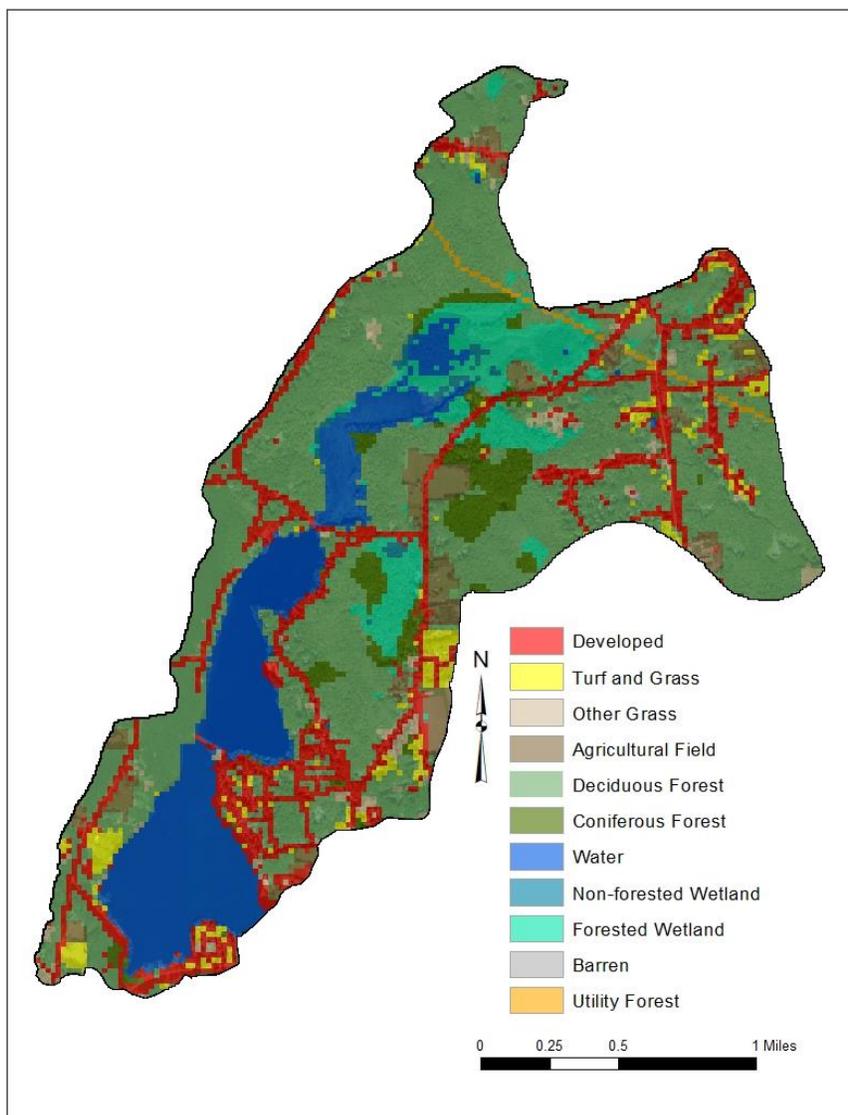
Map 13: CLEAR 2016 Land-Use Coverage

Land-Use	% of watershed
Developed	14.9%
Turf/Grass	3.5%
Other Grass	1.7%
Agricultural Field	4.8%
Deciduous Forest	46.5%
Coniferous Forest	4.4%
Water	16.1%
Non-forested Wetland	0.6%
Forested Wetland	6.9%
Barren	0.1%
Utility Forest	0.6%

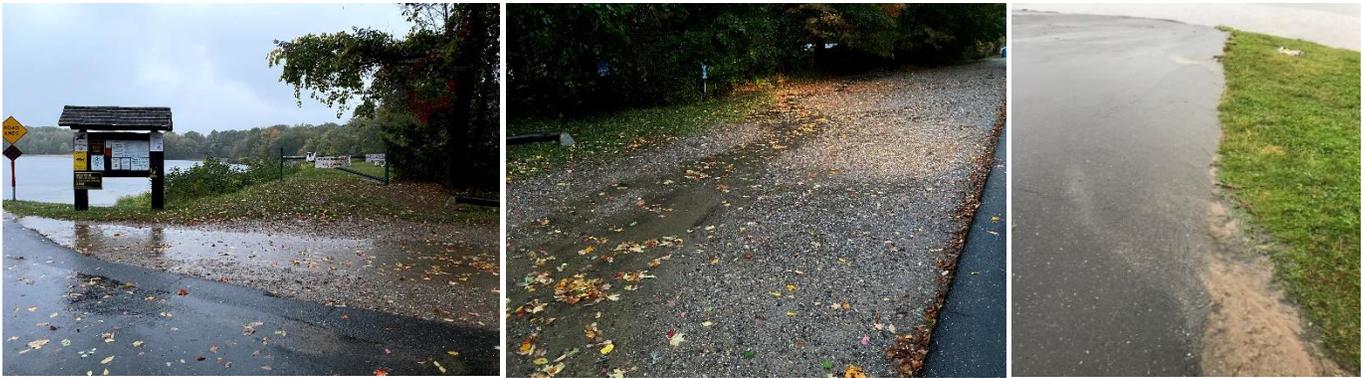
Alternatively, establish pervious interlocking pavers, filled with pea gravel, in the parking area to minimize water runoff and erosion. Sheet flow collects on the edge of the grass (third photo) because there is no break in the long, paved driveway, sloped to the lake. Reduce sheet flow with two horizontal trench drains in the pavement that route water to the west side of the driveway into the densely vegetated swale.

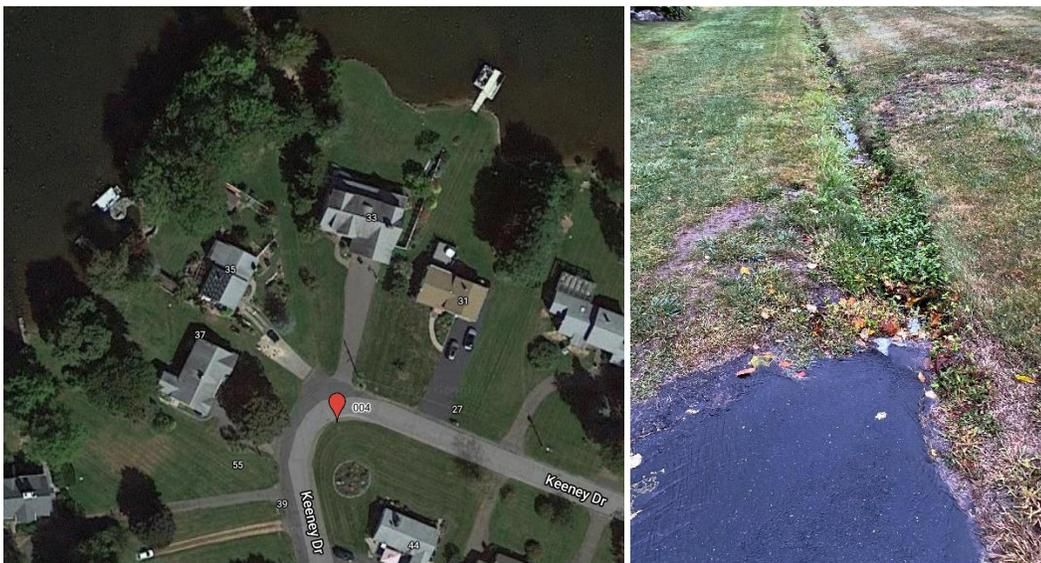
Keeney Drive Road Runoff: The corner of Keeney Drive receives stormwater overland flow from both directions. Some of the water flows underground through culverts to the lake, while some runoff is channeled through a surface stream along a private property boundary, pictured in the photo below. It may be possible to direct more of the road runoff into this vegetated channel instead of direct culvert flow to the lake. The channel would need to be more densely vegetated and could serve as a grassy/wildflower property barrier – whatever grows best with a ‘no-mow’ policy.

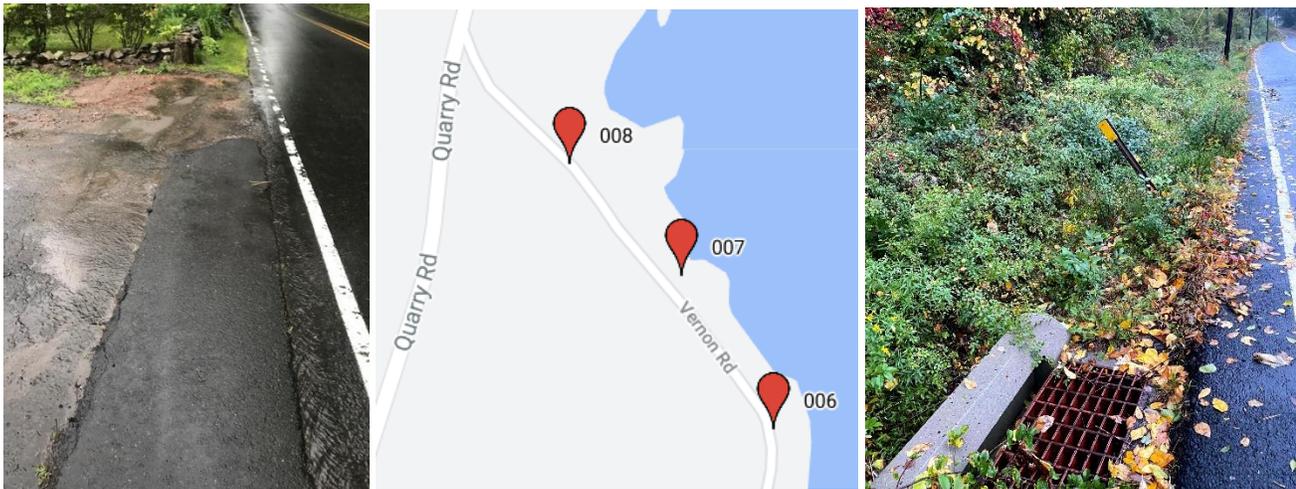
The STEPL and Region 5 models estimate up to 38% phosphorus removal efficiency for sand filters, and the Fabco phosphorus filters would likely see further enhanced phosphorus removal and significant nitrogen reduction, simply from entrapment of fine organic material.

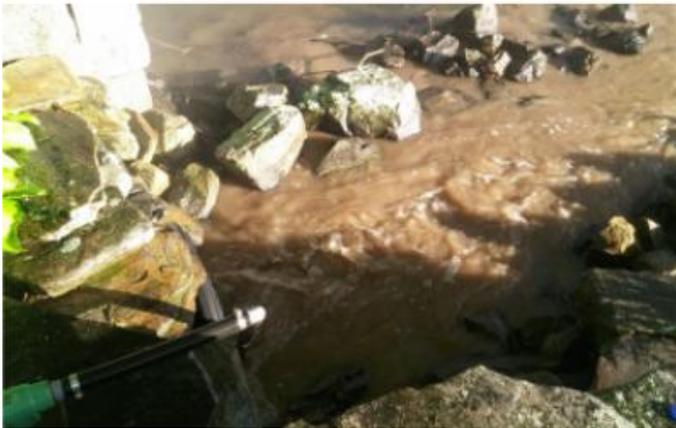
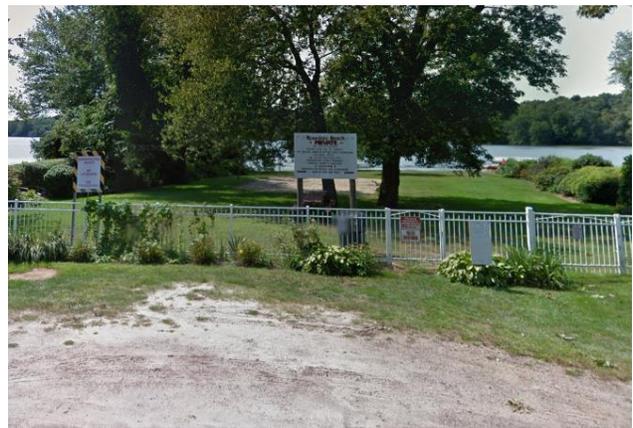
Rosedale Beach has high phosphorus, nitrogen, and turbidity from uphill sources. There are a series of residential gardens in the area that have a combination of open sediment and mulched segments that are very close to the road. When it rains heavily, the garden soil has been seen washing onto the street and into the culvert. There have also been small residential construction projects, such as driveway refinishing and stockpiling soil, that did not have proper erosion control. This tightly knit residential area deserves focused outreach and signage about homeowner BMPs to prevent soil loss and reduce fertilizer use.

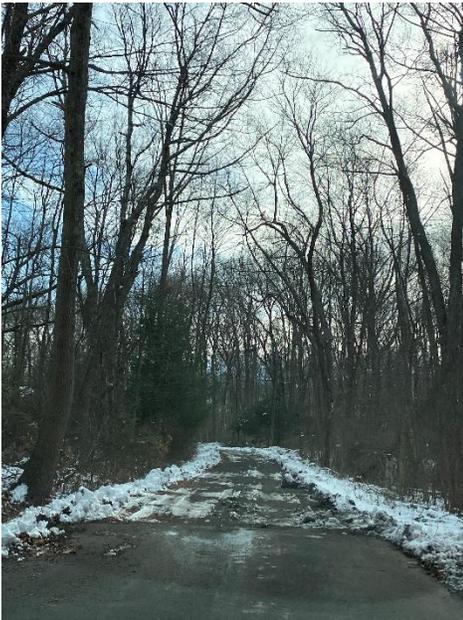
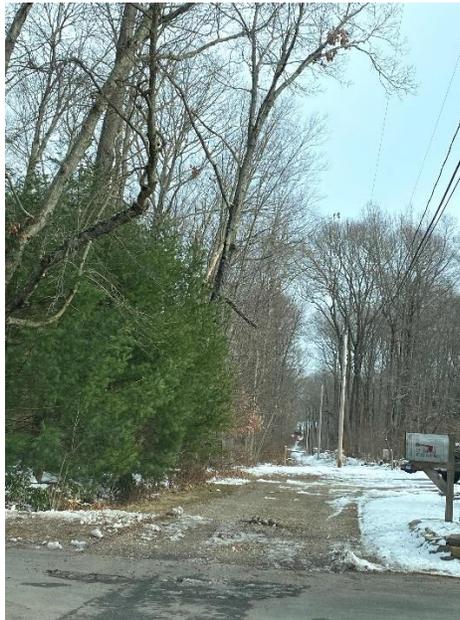
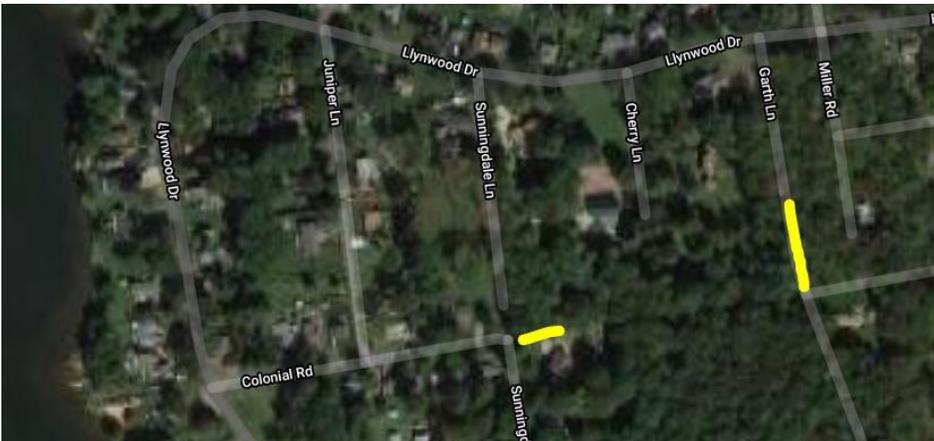
Open soil on unmaintained unpaved surfaces, either roads or private driveways, has the potential for stormwater-induced soil erosion. These roads are relatively flat, which greatly reduces the chance that high turbidity stormwater runoff will reach the lake directly from these streets, but the area needs further investigation. Evidence of water pooling and erosion on the unpaved roads is present, and vehicle traffic tracks soil onto the paved road, which contributes to high turbidity and phosphorus in stormwater runoff to the lake. The yellow lines in the aerial image, below, indicate the sections of road from the photos. This was a major problem in 2021.

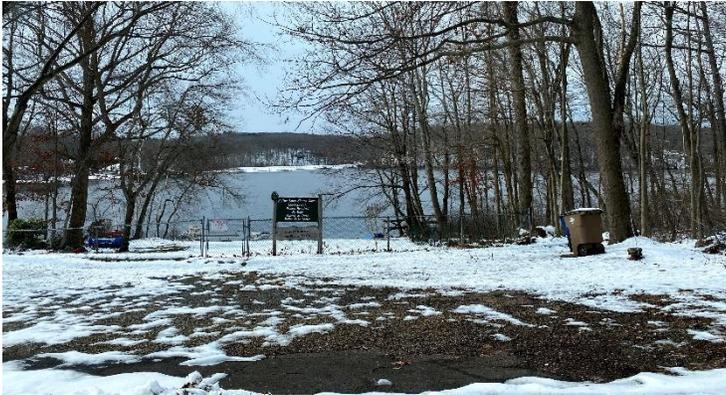
Bolton Lake Shores Association Area (Middle Bolton Lake): The Bolton Lake Shores Association beach has a catch basin that receives runoff from Anchorage and Miller Roads (sampling point 21). There are no recent stormwater runoff samples from this location, but the underground culvert from the catch basin is directed to the lake. There is a gravel entrance way that is presumably used as a parking or loading area, but since all members are local, the gravel area space may be suitable for a stormwater bioretention area (rain garden). A soil test pit would be required to determine if the soils have adequate infiltration abilities to completely infiltrate a 1-2" rainstorm. The rain garden overflow could be directed back into the catch basin.

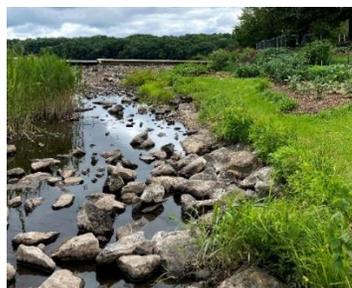
Middle Bolton Dam: The native rock that was used for the construction of the Middle and Lower Bolton dams has a large amount of Brimfield Schist, described as sulfidic schist and gneiss. The ERT report makes note that these rocks contain iron-sulfide minerals that easily break down and erode to iron oxide powder. Iron oxide rapidly binds available phosphate, and high iron concentrations in Lower Bolton have been linked to increased cyanobacteria abundance. Samples from the dam should be taken and put through a series of sediment phosphorus extractions to determine the amount and potential bioavailability of phosphorus from degrading dam materials. The extraction should be as follows: water soluble P, loosely-sorbed P (NH_4Cl extraction), reductant soluble P (CDB extraction).

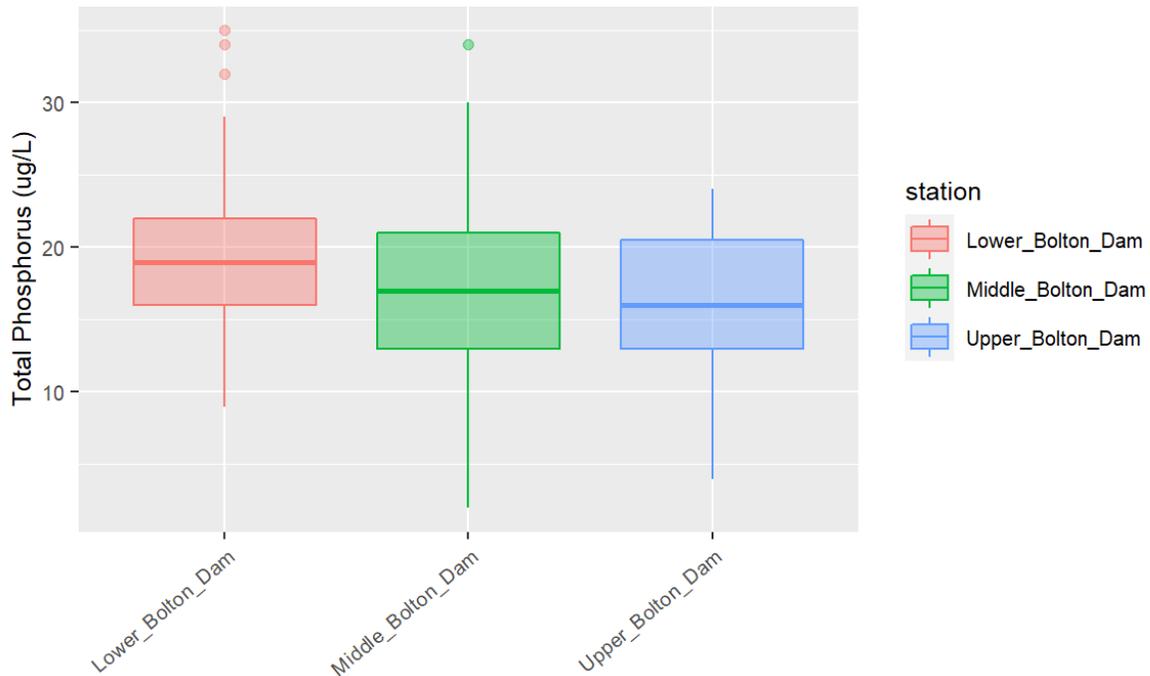
Figure 17: Total Phosphorus at Bolton Lakes Dams

Dam water flows were measured during sampling events and used to estimate mass of phosphorus from Middle to Lower Bolton via the spillway. The 2019 estimates were approximately 25kg TP from April 17th to October 19th, with almost all flow occurring before mid-June. Water rarely flows over the Middle Bolton spillway from late June to October, except in years with high summer rainfall. An additional nutrient flush from Upper to Middle to Lower Lake occurs during the annual drawdowns. Based on 2020 estimated calculations, the TP mass transfer from Middle to Lower during drawdown is around 10kgs, depending on in-lake concentration. The understanding of nutrient mass transfer during drawdowns will be updated based on the detailed water level logger data, but generally these rough nutrient mass estimates align with range of in-lake measured phosphorus mass per year, which were used to determine target nutrient mass thresholds to maintain Mesotrophic conditions in Lower Bolton Lake. Target nutrient mass thresholds were not calculated for Middle Bolton Lake, given a lack of significant historical in-lake sampling.
