# **Bolton Lakes & Watershed Management Plan**

Prepared by Northeast Aquatic Research LLC

The Watershed Management Section of this plan was written to address the Nine Key Elements identified by the Environmental Protection Agency (EPA) that constitute a watershed remediation and/or protection plan.

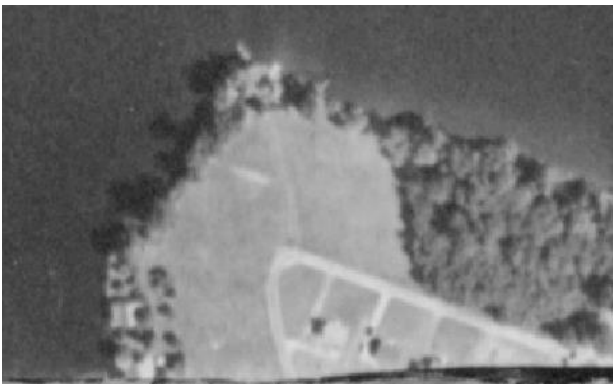
*Photo 1: 1951 Aerial Image*

Residential development was heaviest in the 1950-1970s. Pictured below is an aerial comparison photo of the Keeney Drive neighborhood on the southern shore of Lower Bolton Lake from 1951 to 1970 (Photos 1 & 2). The residential neighborhoods along the shoreline and lake-access communities also slowly transitioned from seasonal cottages to full-time residences.

Overall, historical aerial photos of the lakes show that there was substantial deforestation and development in the watershed in 1951 (Photo 1 & 3: Aug 6, 1951), but by 1970 (Photo 2: March 10, 1970) there were substantially more residential homes along the shoreline. By 1990 there was much more residential development, particularly in the Lynwood Ave. neighborhood (Photo 4: April 19, 1990). The Lower Bolton Lake public beach and Indian Notch Park were created at some point between 1970-1986, and the park was greatly expanded between 1990-1995, based on aerial imagery (Photo 5: April 25, 1995).

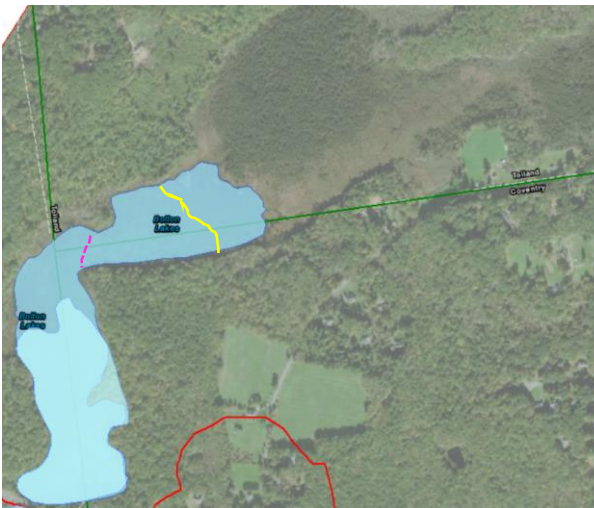
Photo 6: Upper Bolton - October 2020

The above Upper Bolton Lake photos were taken roughly at the central location of the yellow line. Waterlilies were dying back in October 2020 and water depth at the time was roughly eight inches. The second photo shows the transition area, from water/lily-coverage to peat-lands and swamp, with the Atlantic White Cedar Forest to the northeast. The red arrow points roughly north.

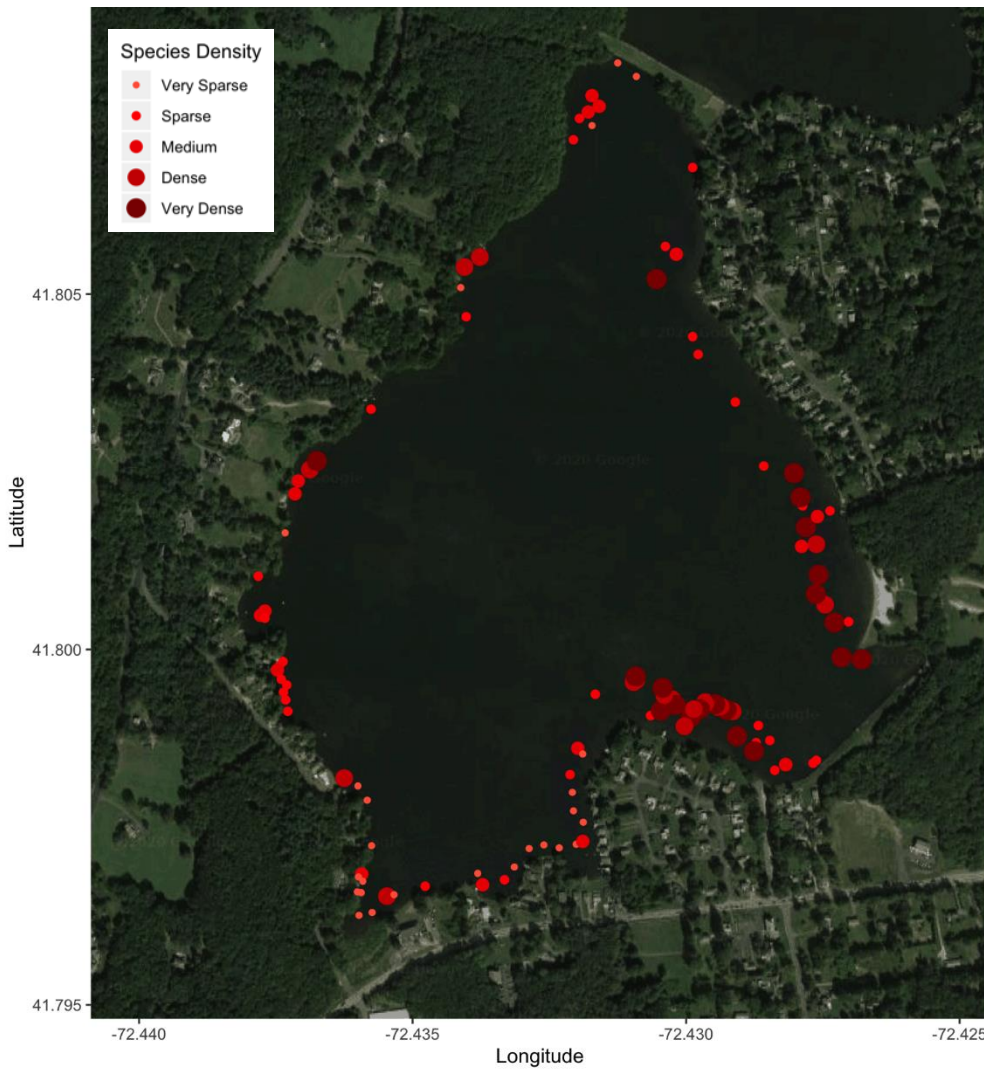
Map 10: Lower Bolton Invasive Curly-leaf pondweed (*Potamogeton crispus*) May 22 & Jun 22, 2020

Because of a permit issue, there was no herbicide treatment in 2019. The permit issue was resolved by the applicator in 2020, but by late June 2020, the invasive species had spread to new areas, particularly along the southwestern shore. The turion formation had begun prior to the 2020 treatment date, so we expected that another Curly-leaf treatment will be needed in 2021.

The typical late June treatments for Curly-leaf pondweed are not ideal, the treatments should ideally occur before turions begin to form in early June. There have been multiple years where CT pesticide permits were not received in time to attack Curly-leaf pondweed prior to turion formation. As of 2020, CT DEEP has begun to grant multi-year lake treatment permits to avoid permit delays that negatively impact management. FBL and the Town of Bolton must work with the applicator and CT DEEP to ensure that treatment happens prior to the time when turions develop to avoid spread.

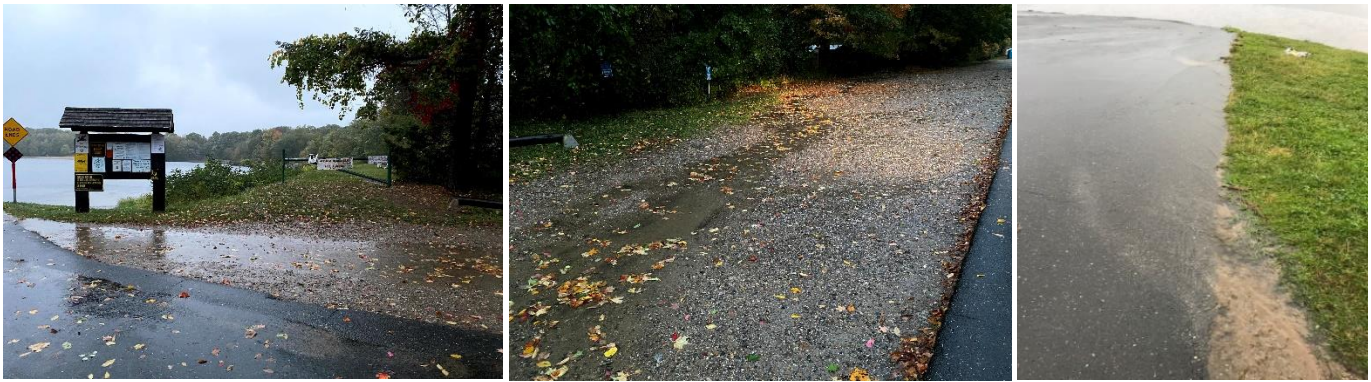
Alternatively, establish pervious interlocking pavers, filled with pea gravel, in the parking area to minimize water runoff and erosion. Sheet flow collects on the edge of the grass (third photo) because there is no break in the long, paved driveway, sloped to the lake. Reduce sheet flow with two horizontal trench drains in the pavement that route water to the west side of the driveway into the densely vegetated swale.

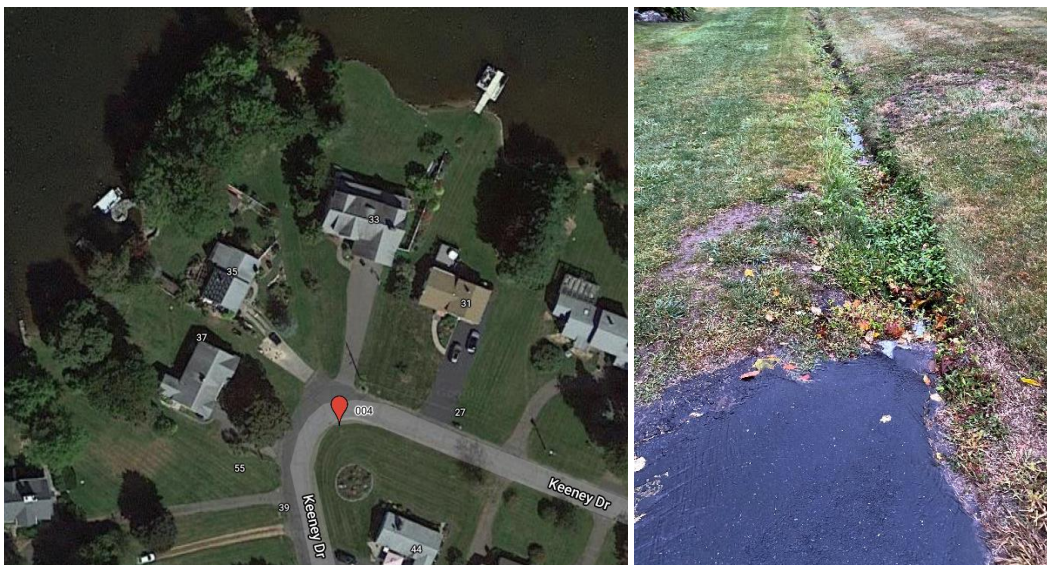
**Keeney Drive Road Runoff:** The corner of Keeney Drive receives stormwater overland flow from both directions. Some of the water flows underground through culverts to the lake, while some runoff is channeled through a surface stream along a private property boundary, pictured in the photo below. It may be possible to direct more of the road runoff into this vegetated channel instead of direct culvert flow to the lake. The channel would need to be more densely vegetated and could serve as a grassy/wildflower property barrier – whatever grows best with a ‘no-mow’ policy.

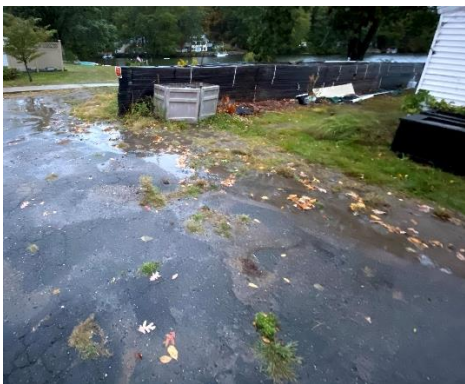
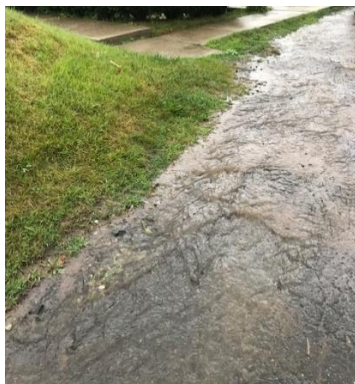
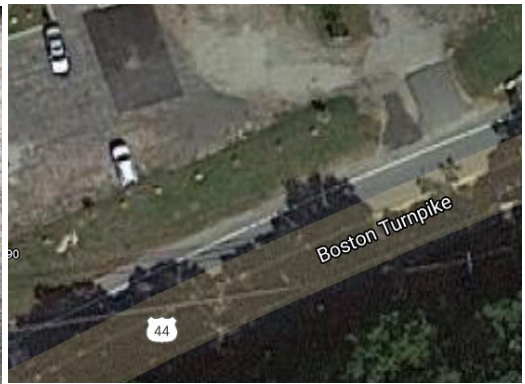
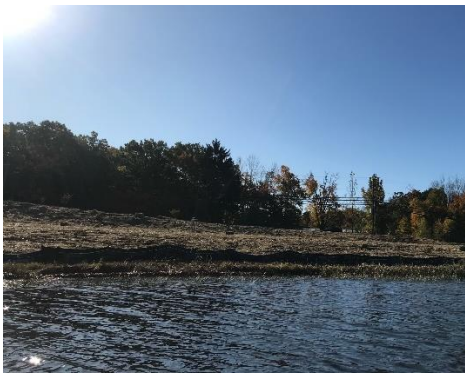
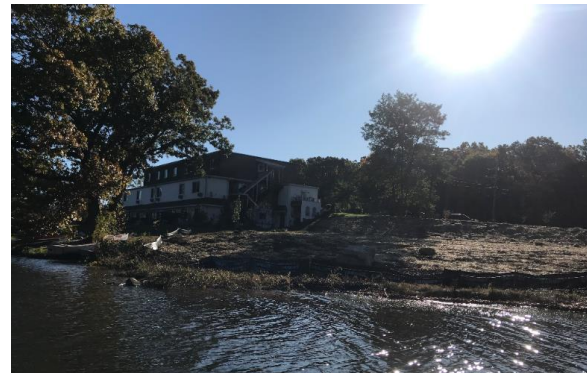
**Apartments on Route 44 & Vernon Rd. along Lower Bolton Lake:** The old parking lot of the apartment building has large areas of exposed sediment that increase the turbidity of local stormwater runoff. Because this property is private, there has been very limited stormwater inspection. The first photo included was taken during a small rain event and does not fully demonstrate the extent of flooding and erosion that occurs on the lower half of this property. The second photo demonstrates how rainwater washes through the old driveway and picks up turbidity before flowing to the lake. It is worth pursuing a public-private partnership to improve general stormwater practices for the entire parcel. It is also possible to improve the section of the driveway closest to Rt. 44 and direct driveway runoff into a large bioretention area in the grassy area along Rt. 44, or to the east of the property.

After the large de-vegetation and soil disruption event in October 2019, it is clear that the lakes management effort would benefit from improved communication with this property owner. The photo of the silt fence was taken from the water, but it took months to properly seed this area, and a well-vegetated shoreline buffer was lost. It is unknown if there was Inland Wetlands oversight or enforcement at the time.

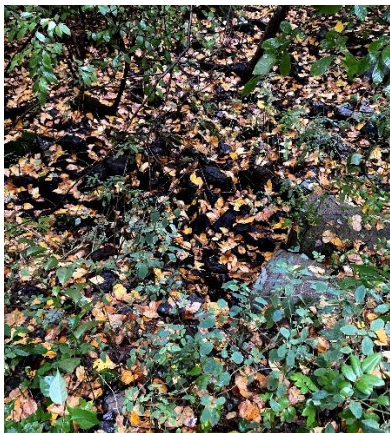
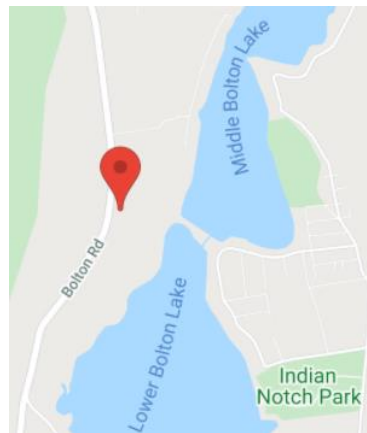
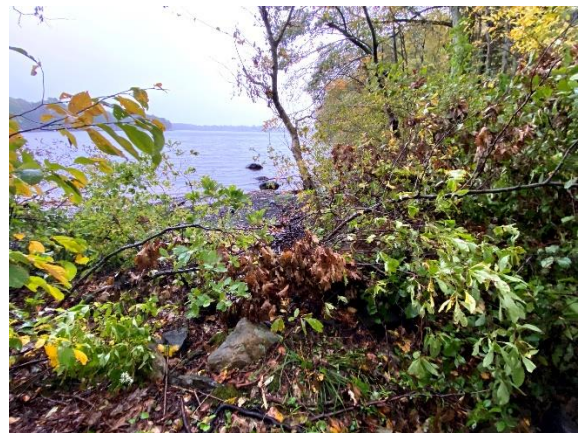
**Bolton Road Wetland Enhanced Filtration:** A large amount of direct road runoff from the watershed’s northern half of Bolton Road flows through two large cement culverts under the CT DEEP-owned walkway. While the wetland does a good job dispersing and storing such large quantities of water during the drier summer months, the water could be better dispersed through both the north and south sections of the wetland via a series of natural level-spreaders. Level-spreaders are designed to create temporary and shallow pools of water across wide sections of wetlands to increase maximum flood-storage capacity of the wetland and increase the amount of nutrients and organic matter that can settle out (by increasing retention time).

The level-spreaders are similar to dam jams or weir boards that allow water to flow over them during peak flow and then slowly lower the water level through a small opening closer to the bottom of the board. The area just uphill and downhill of the cement culverts would be the best place for this type of system as water already naturally pools in those areas and site access would be easy. The exact location is marked with a Google Maps pins below.

Similarly, the lower reach of the wetland, just before the stream enters Lower Bolton Lake, could be further dechannelized. The simplest method of doing so would be to place several medium sized rocks/small boulders upslope of the inlet. Rocks disperse water energy and decrease channel erosion, which is present at the inlet during almost all rainstorms (less during summer months, due to recent drought conditions – inlet location visible third photo).

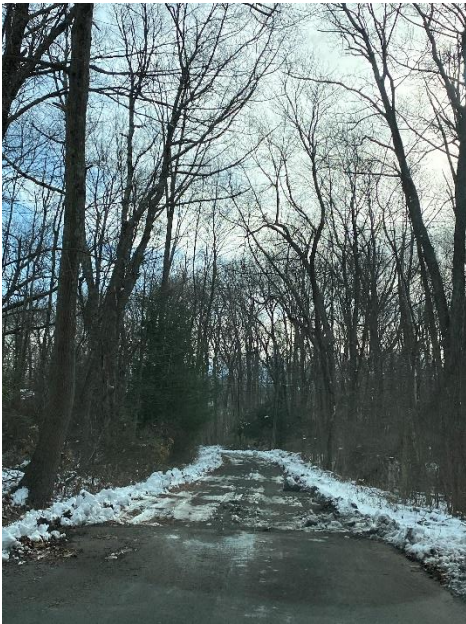
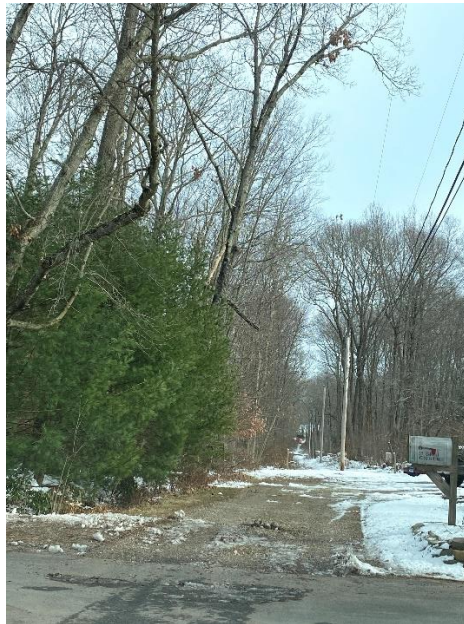
Open soil on unmaintained unpaved surfaces, either roads or private driveways, has the potential for stormwater-induced soil erosion. These roads are relatively flat, which greatly reduces the chance that high turbidity stormwater runoff will reach the lake directly from these streets, but the area needs further investigation. Evidence of water pooling and erosion on the unpaved roads is present, and vehicle traffic tracks soil onto the paved road, which contributes to high turbidity and phosphorus in stormwater runoff to the lake. The yellow lines in the aerial image, below, indicate the sections of road from the photos. This was a major problem in 2021.

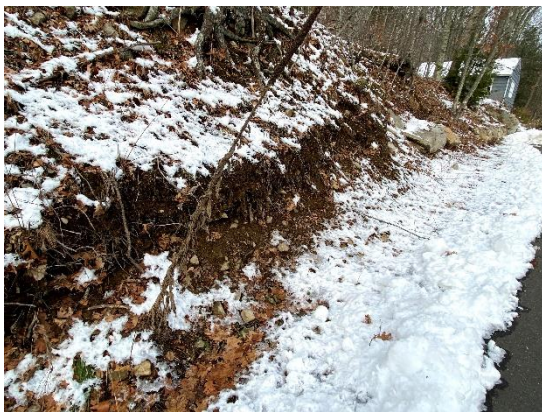
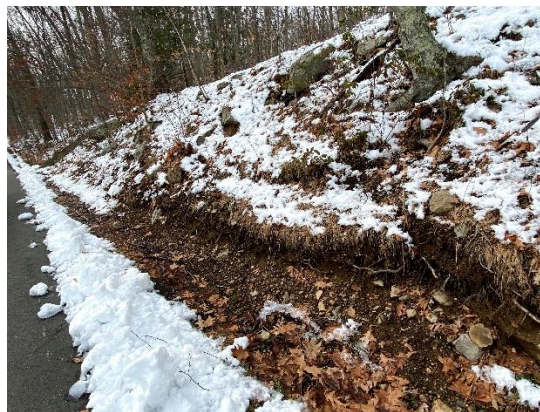
There is also a stream that runs underneath Wildwood Road at sampling point 10, before intersecting the lower Wildwood Road S. at sampling point 10B. The water quality of this stream has been good, but any increased development in the forested area could impact the stream and increase nutrient loading. Preserving this forested section of the watershed should be a priority. The second aerial image displays the property parcels and the location where the stream crosses the road.

The sampling points 11 and 12 are very small streams that appear to flow only during heavy rain (>2"). Nutrient concentrations from 2014-2015 were very high, but those values were a result of poor erosion control during construction at the time. There are no updated stormwater samples and these sites were not flowing during recent stormwater samplings.

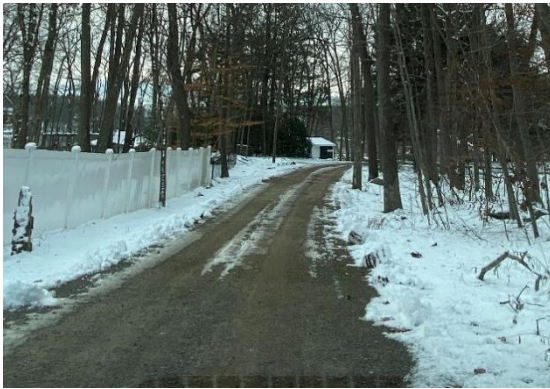
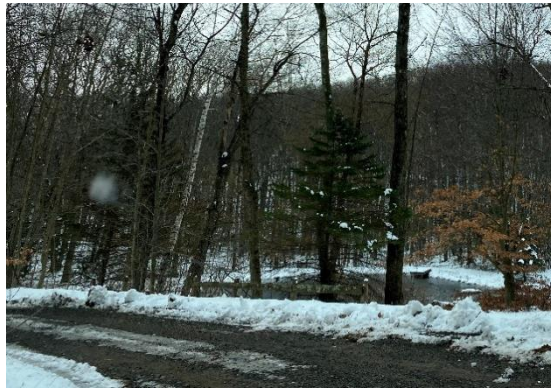
**Wheeler Road and Lakeview Drive Middle Bolton Residential Communities:** These two residential unpaved roads in the Middle Bolton near-shore watershed have high potential for erosion and phosphorus loading to Middle Bolton Lake. This area should be a priority for further watershed reconnaissance, led by the community members. At present, there are two small streams (sampling points 15 and 16) that flow from the forested area and under the roads. Flow from the larger stream (16) is interrupted by a pond on private property on Lakeview Drive. Depending on the private pond maintenance, it could either improve or degrade the stream water quality. Increased water storage allows settling of particles, but if the pond is dug deep enough, it could increase orthophosphate if oxygen loss occurs during summer.

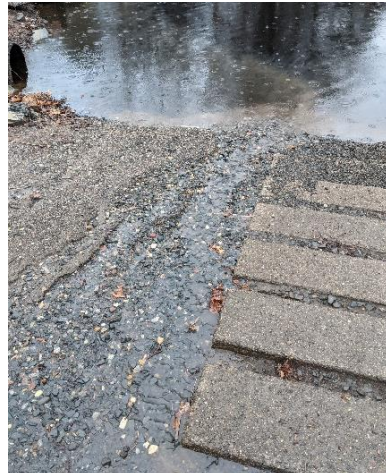
**Middle Bolton CT DEEP Boat Ramp & Parking Lot:** The Middle Bolton public boat ramp is heavily used and has been an ongoing source of high nutrient runoff to the lake for years. The runoff from past years was significantly greater due to active construction and poor erosion control, but even today, the gravel lot has many pot-holes and evidence of erosion. During heavy rain, sheet flow runoff carries silt and gravel across the boat ramp and channelizes along the Hatch Hill side of the boat ramp. The photos below do not show the full extent of the stormwater runoff, but frequent sediment plumes are witnessed after and during rainstorms, indicating high phosphorus loading potential. There are many potential LID and stormwater infiltration projects that could improve the water quality impact of this large parking lot. It is unknown if the Hatch Hill dam reconstruction project will impact this site, but any amount of erosion is not good for water quality. In the future, this boat ramp site would be a good spot for a large infiltration rain garden and educational stormwater signage.

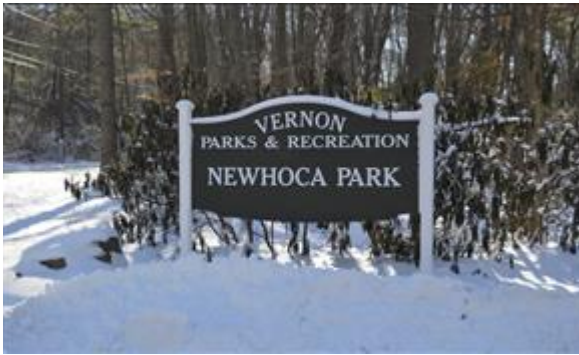
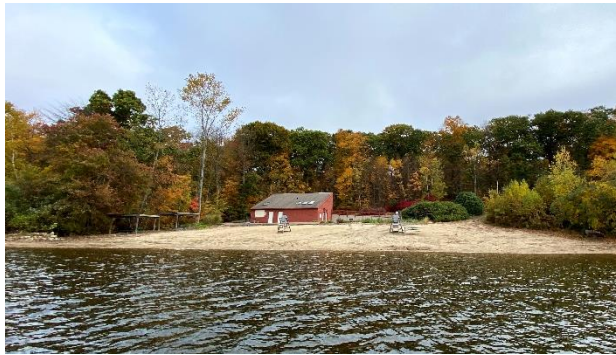
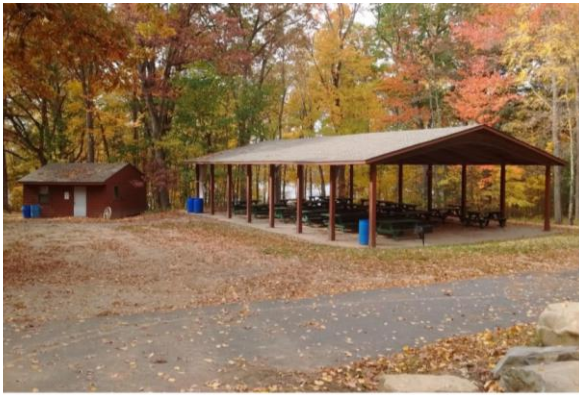
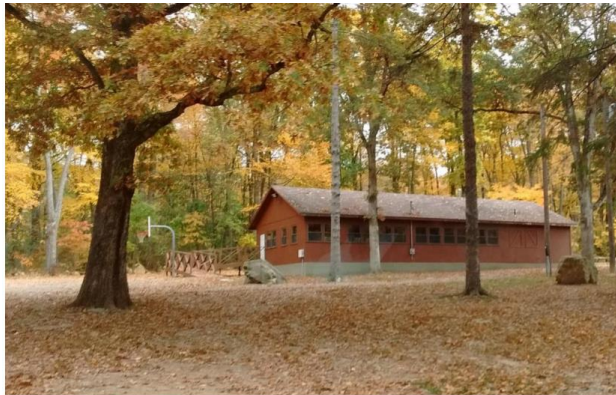
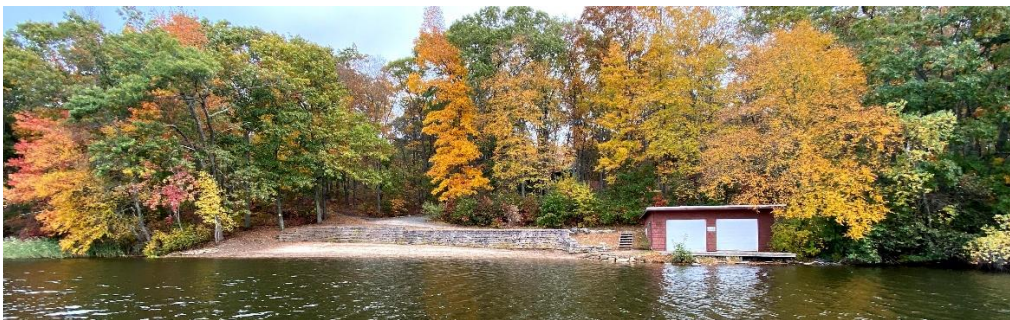
**Camp Newhoca – Vernon Public Park, shore of Middle Bolton Lake:** Camp Newhoca is owned and operated by the Town of Vernon. The Park offers beach access to Middle Bolton Lake. The Newhoca Park offers use and rental of the Town-owned and maintained pavilion and lodge. This large parcel of municipal land should have maintenance practices that aim to reduce stormwater runoff and overall impact to the lake’s water quality. Beach maintenance should only use washed sand, which is cleaner and low in phosphorus. The large beach parking lot area deserves further inspection and may benefit from LID and/or bioretention areas in the future.

The second beach zone, which is separate from the main public beach, appears to have infrequent use. Depending on the Town’s proposed future use of this area, it would be a good example for private property owners if the Town allowed a driveway buffer area to grow and fill in on the upslope side of the retaining wall. Native wildflowers and grasses require little effort to establish, and would have visual and functional utility.

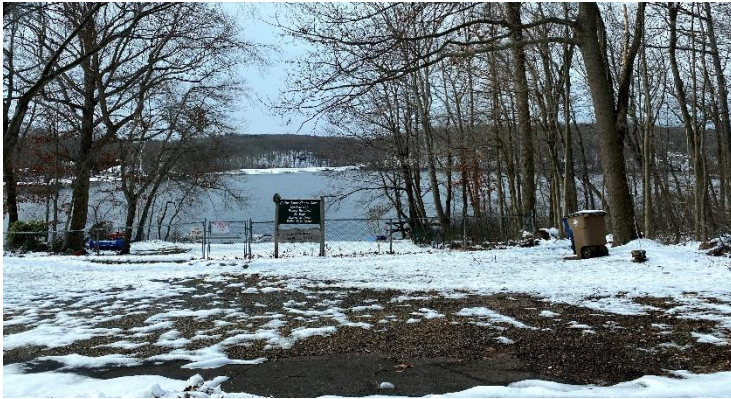
**Bolton Lake Shores Association Area (Middle Bolton Lake):** The Bolton Lake Shores Association beach has a catch basin that receives runoff from Anchorage and Miller Roads (sampling point 21). There are no recent stormwater runoff samples from this location, but the underground culvert from the catch basin is directed to the lake. There is a gravel entrance way that is presumably used as a parking or loading area, but since all members are local, the gravel area space may be suitable for a stormwater bioretention area (rain garden). A soil test pit would be required to determine if the soils have adequate infiltration abilities to completely infiltrate a 1-2" rainstorm. The rain garden overflow could be directed back into the catch basin.

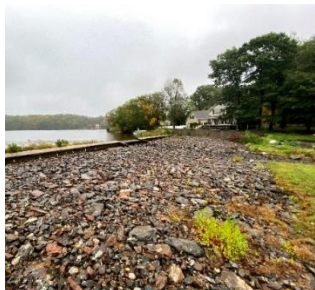
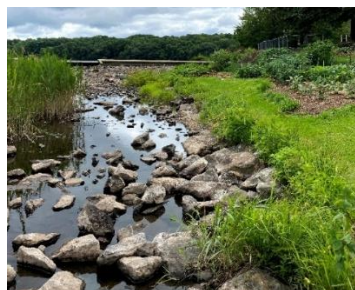
**Middle Bolton Dam:** The native rock that was used for the construction of the Middle and Lower Bolton dams has a large amount of Brimfield Schist, described as sulfidic schist and gneiss. The ERT report makes note that these rocks contain iron-sulfide minerals that easily break down and erode to iron oxide powder. Iron oxide rapidly binds available phosphate, and high iron concentrations in Lower Bolton have been linked to increased cyanobacteria abundance. Samples from the dam should be taken and put through a series of sediment phosphorus extractions to determine the amount and potential bioavailability of phosphorus from degrading dam materials. The extraction should be as follows: water soluble P, loosely-sorbed P ( $\text{NH}_4\text{Cl}$  extraction), reductant soluble P (CDB extraction).

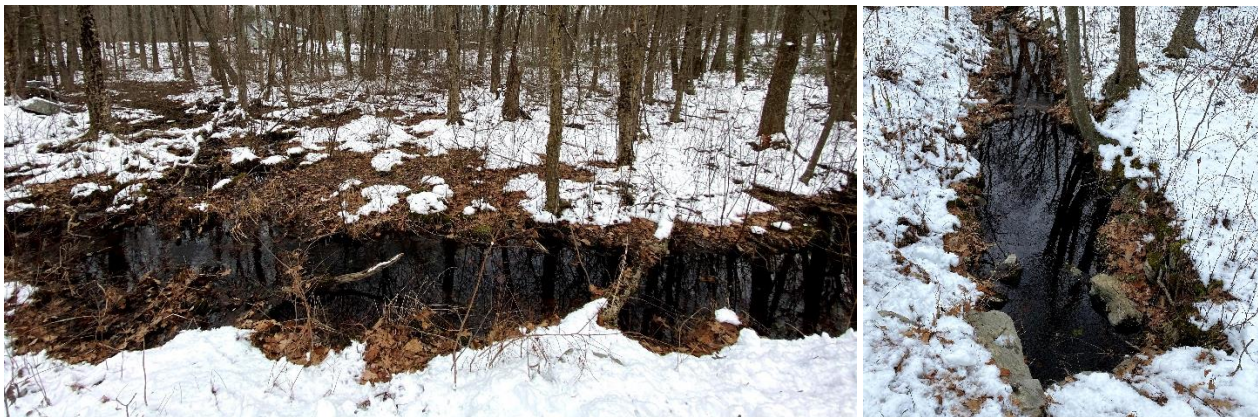
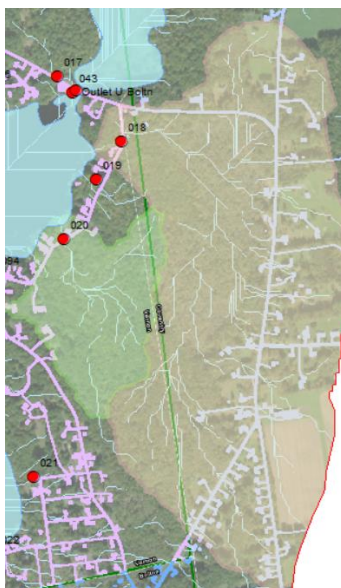
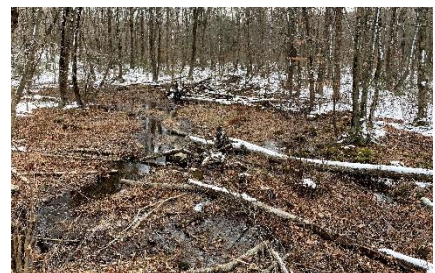
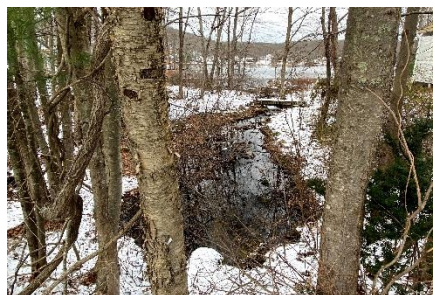
**Grier Road Wetland Streams & Road Runoff to Middle Bolton:** There are three wetland streams that cross under Grier Road (sampling points 18, 19, and 20). Road runoff from Grier Road makes its way to these streams during heavy rain and increases the nutrients that feed into Middle Bolton Lake. The wetland streams, themselves, also contribute phosphorus and nitrogen to the lake. A wetland's ability to retain nutrients is dependent on the amount of settling time and plant growth. The wetland that feeds stream 18 is channelized and most of the water flow runs closely alongside Grier Road, shown in the first and second photos. A wetland enhancement project could reroute some of the water across more wetland surface, with the goal of increased settling and nutrient storage. Though, stormwater concentrations of these wetland areas are relatively low compared to other locations noted in this watershed plan, meaning this is not a high priority management site.

The Grier Road runoff currently flows to the roadside forested areas, and due to the low slope, does not have issues with erosion. It is unknown whether the Town does roadside vegetation maintenance, but roadside ferns and grasses enhance stormwater infiltration, before overflowing to the wetlands. The second photo shows the approximate sub-watersheds and flow direction for streams 18 and 20, created using the CT 1m LIDAR DEM data. The forested area that flows to these inlets is important to preserve.

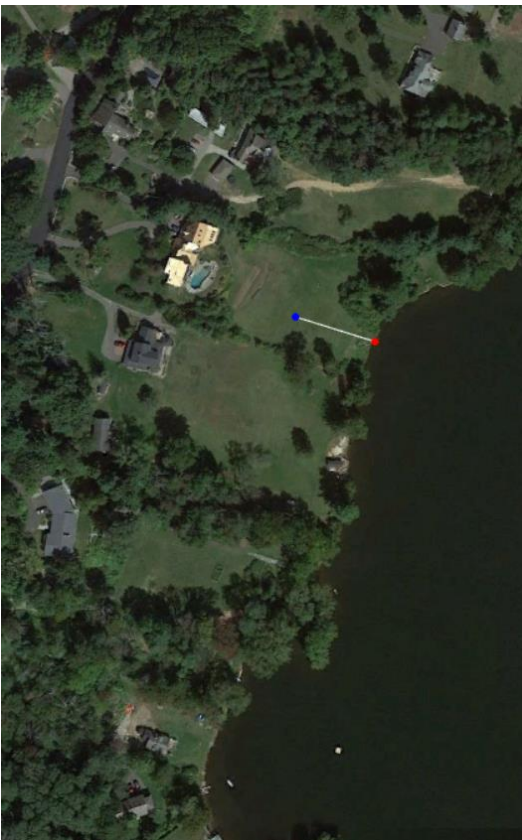
**Whole Watershed Shoreline- Encourage Private Residential Buffer Zones:** There are a number of private residential properties around Lower Bolton Lake (first image) that have room to improve their shoreline buffer zones. Ideally, a buffer zone should be 150ft wide, measured perpendicular to the lake shoreline. An example of 150ft is shown on both aerial images. While there is not enough room to establish 150ft buffer zones along the more densely populated shoreline, lakefront homeowners with smaller lots can still aim to reduce the lawn coverage and establish narrower no-mow zones, or densely vegetated shores, to limit lawn run-off.

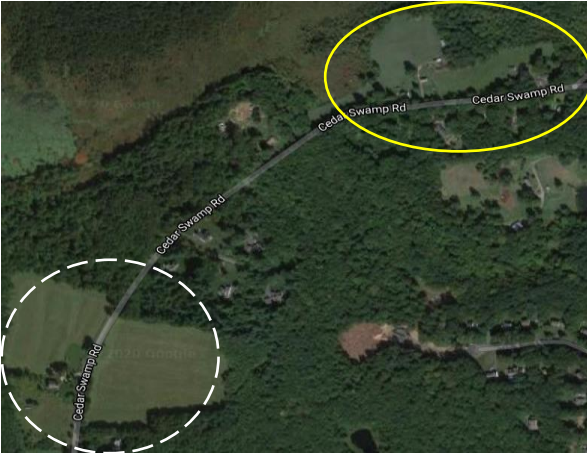
**Agriculture in the Upper Bolton Lake watershed (Coventry):** Several private properties on Cedar Swamp Road are used for agriculture. The yellow circled property is used for cattle grazing and has a small stream that feeds Upper Bolton Lake through a wetland. No water sampling has occurred, but due to the nature of livestock, this stream presumably presents a substantial nutrient load to Upper Bolton. Property owners are always encouraged to work with the Natural Resources Conservation Service (NRCS) to reduce the impact of agricultural land on nearby waterways. Upper Bolton Lake, however, is a highly eutrophic swamp and should adequately capture most of the nutrient inputs, so the farm likely has little impact on the Middle or Lower Bolton water quality.

The white dashed circled farmland appears to not be used for livestock grazing. The Town of Coventry should continue to work with farm owners and operators to minimize future nutrient loading to Upper Bolton Lake through sustainable agricultural practices. Again, the NRCS will be a valuable partner organization.

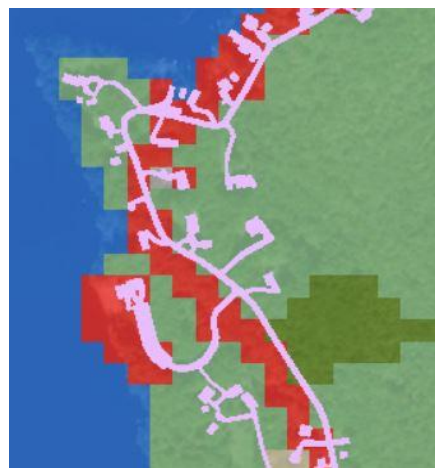
Figure 21: Difference between UCONN CLEAR 2015 Land-Use Pixels & Impervious Cover High Resolution Polygon Layer

LLRM relies on land-use areas per subbasin, such as those provided by the UCONN CLEAR 2015 Land-Use Cover raster GIS dataset. Though, because there are inherent errors within the UCONN CLEAR 2015 Land-Use Cover GIS dataset, the LLRM model was approached in two different ways. Both utilized a single watershed approach, not a 3-lake basins approach, which would have complicated the basic estimate. Instead, the surface waters of UBL and MBL were considered open-water land-uses for both model scenarios. The first used the CLEAR 2015 Land-Use acreages, while the second estimate used the UCONN CLEAR Impervious Cover acreages classified as “High Density Residential.” Scenario 2 used more accurate acreages of wetlands and forested areas given the Hydric Soils of CT GIS layer. Impervious cover is defined as any developed area that does not allow rainfall to pass into the underlying soils, generating stormwater runoff from the entire surface. Paved roads, sidewalks, driveways, houses, and other buildings are all impervious – unless specially designed to infiltrate stormwater onsite. Though the impervious cover dataset does not directly equate to “High Density Residential (HDR)” classification, it is close. The water runoff coefficient for HDR was 0.6 (or 60% runoff), which is the model standard. To the right, a comparison of the overlapped layers is shown to demonstrate the GIS data differences. Both layers are displayed in the same projected coordinate system (NAD\_1983\_StatePlane\_Connecticut\_FIPS\_0600\_Feet) in the image.
